SERVICE BULLETIN

Subject: **Accessory Port Power Supply Issue - Possible Inverted Wires at Vehicle Connector**

No. **2020-7**

REVISION 1
April, 2021

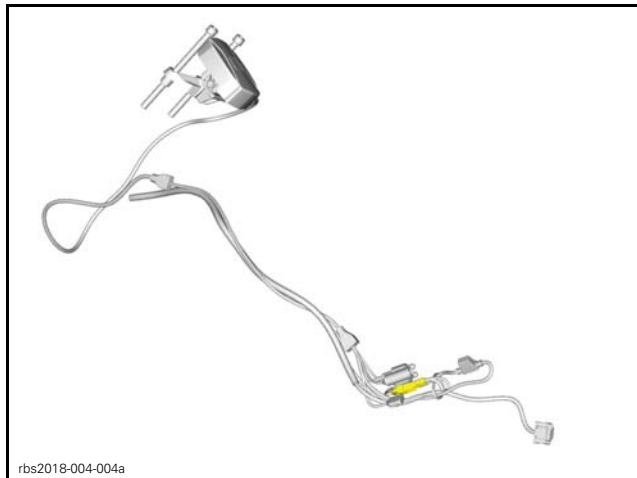
Vehicles equipped with GPS kit may experience inner battery charging issues. One of the probable cause is inverted wires at vehicle connector

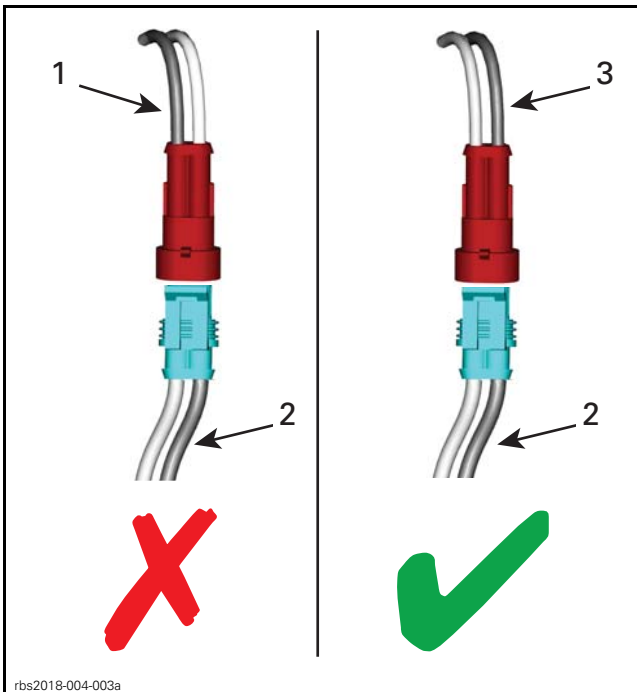
1. Black wire on female connector at the wrong location
2. Black wire on male connector
3. Black wire on female connector at the appropriate location

2. Make sure the black wire on the male connector is on the same side as the female connector.
