SERVICE BULLETIN

APPLICABILITY: 2013-14MY Legacy and Outback Models
 with 2.5L FB Engines
 2011-14MY Forester Models with 2.5L FB Engines
 2015 MY Forester (Manual Transmissions Only)
 with 2.5L FB Engines
 2012-13 MY Impreza and XV Crosstrek Models
 with 2.0 FB Engines
 2014-15 MY Impreza and XV Crosstrek Models
 (Manual Transmissions Only) with 2.0 FB Engines

NUMBER: 02-157-14R

SUBJECT: Engine Oil Consumption

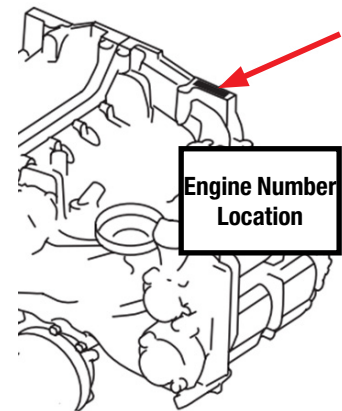
*** NOTE:** When determining the engine number, use the **LAST 8** characters of the number stamped into the boss on top of the block adjacent to the starter and shown in the illustration. The engine number range for the FA1 assembly line is 800000 to 930025 and the FB2 range is 000000 to 652640.

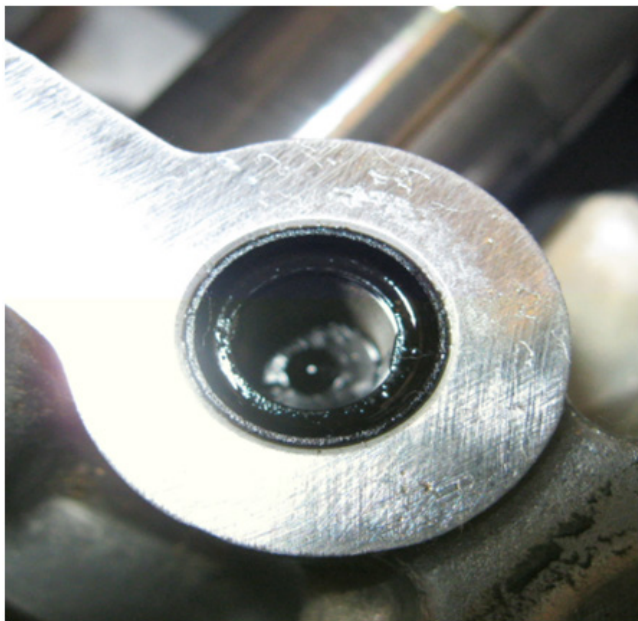
Cam Carrier Filter Screen

- Don’t forget to replace (**one-time use**) the filter screens in the cam carriers. In addition, always be sure to do a thorough inspection and cleaning of the oil pan, pick-up tube and screen as shown in the photos below before reassembly.
