Technical Service Bulletin

94 Various warnings displayed in cluster, DTCs U121C00, U011000, U003600, U002800, U002900, U140500, P0A2F00, P0A1B00

94 21 37 2063075/1 April 30, 2021.

Model(s)	Year	VIN Range	Vehicle-Specific Equipment
Q5	2018 - 2020	All	PHEV
Q5	2021	000001 - 079893	PHEV

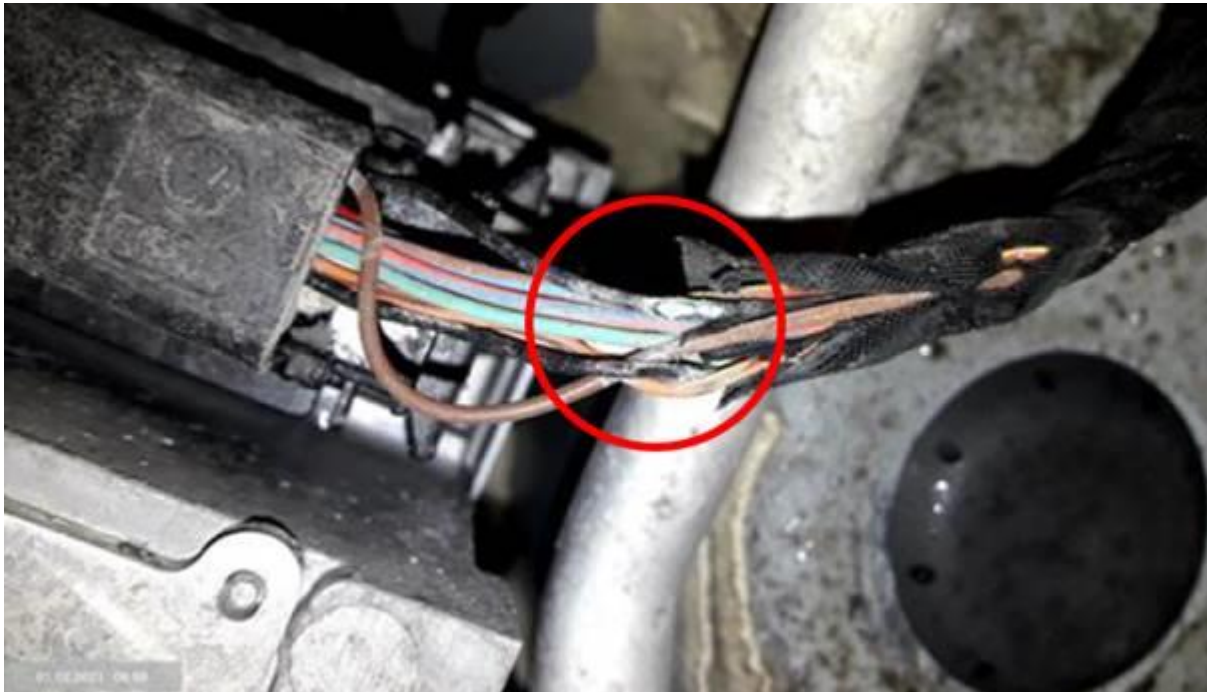
The 12V wiring harness for the power electronics, J841 (address word 0051) can chafe against the underbody trim.

1. Check the wiring harness for the power electronics, J841 (address word 0051) for any chafed sections (Figure 1).

Figure 1. Chafed 12volt harness section.

2. **A.** If there is no damage found, this TSB does not apply please continue with normal diagnosis outside of this bulletin.
B. If damaged wires are found, please document the damage following TSB 2061976: *97 Wire harness repairs and documentation.*
3. Repair the wires with VAS 1978B. If it is necessary to replace the contacts in the connector as part of the repair work, please use gold-plated repair wires 000 979 038 EA.

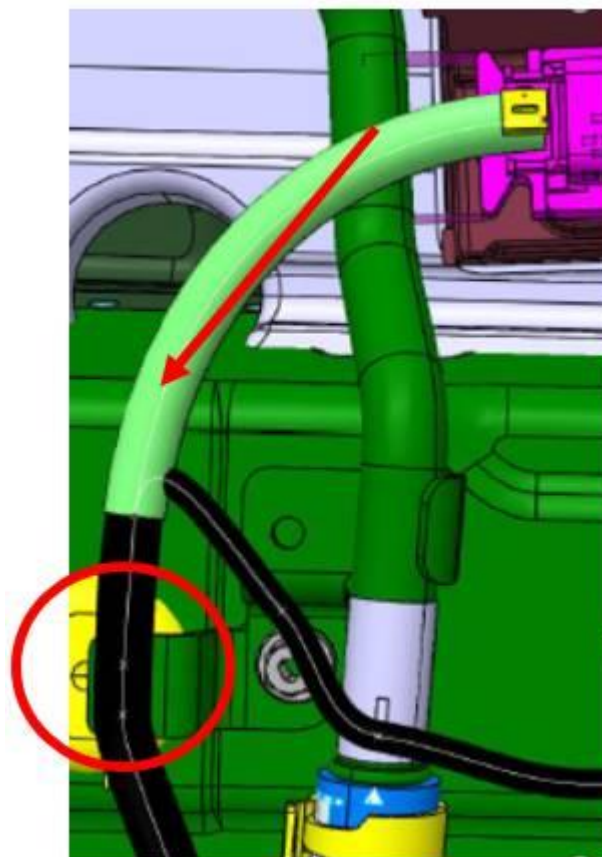
Figure 2. Harness modification diagram.

4. Expose and release retaining clip (see red circle in Figure 2).

5. Pull wiring harness 5 mm (see red arrow in Figure 2) away from power electronics.
6. Secure clip again with textile tape N 107 290 02. Clip must be replaced if it is damaged during removal (part number 6Q0 971 848 P).
7. Wrap textile tape N 107 290 02 around entire wiring harness as far as connector.

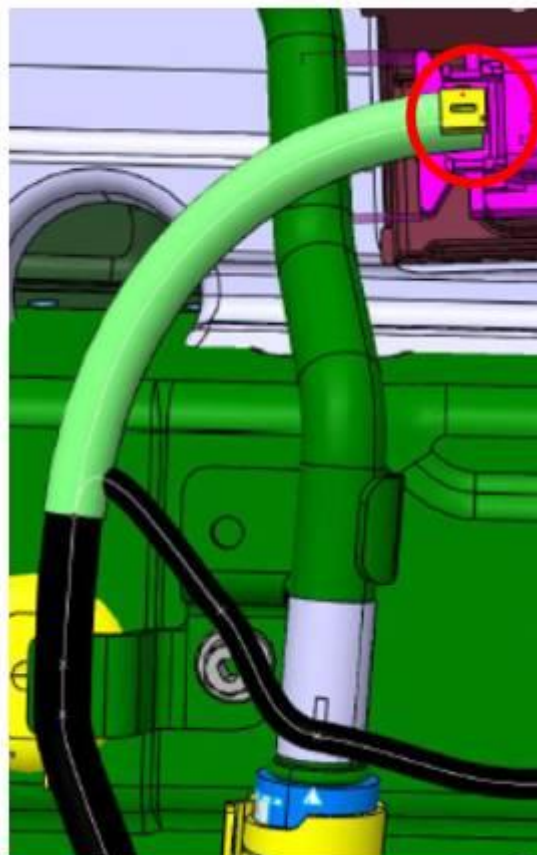
Figure 3. Secure the cable tie.

8. Secure cable tie N 106 232 01 around wiring harness and connector so that wiring harness is pulled upward (see red circle in Figure 3).

9. Ensure the wire does not make contact with any components including the undershield after the repair work is performed.
