Articles Contained in this Issue

Improved Diagnosis of Engine Oil Leakage, Leak Trace Powder Revisited (CONTINUED)

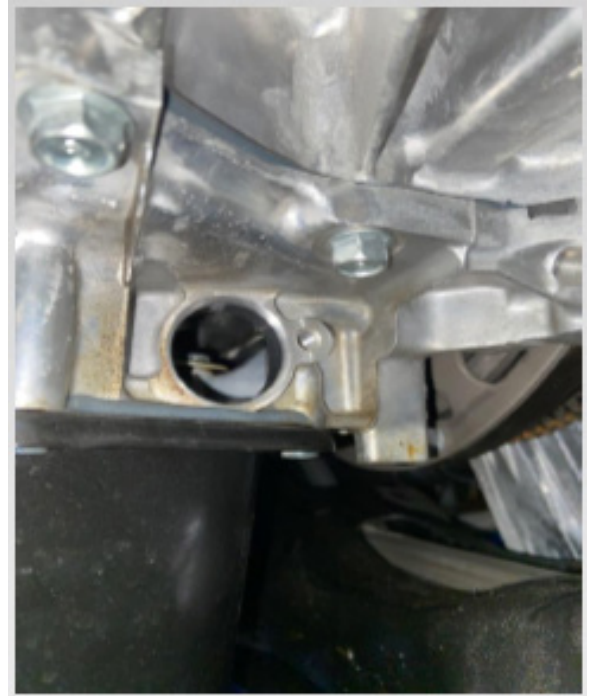
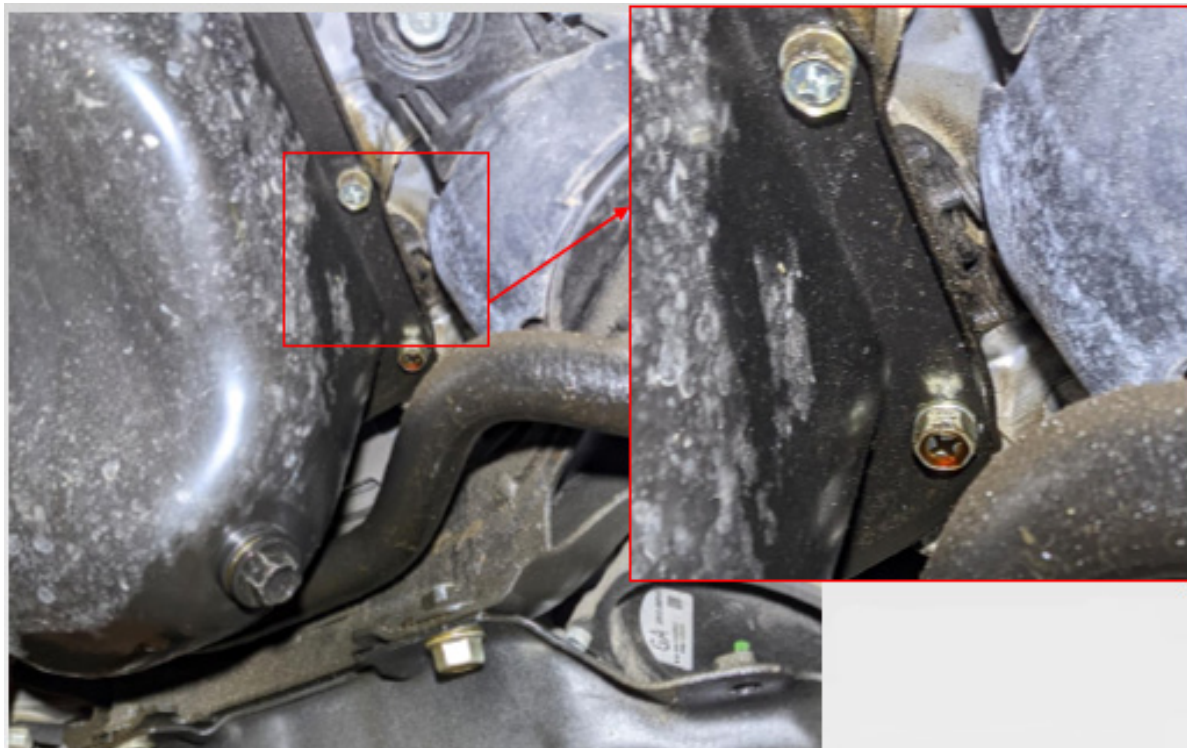
Here is an example: a Technician finds oil seepage and drips forming at the back of the oil pan and thought it was coming from the oil level switch gasket. So, the Technician removed the switch, cleaned the surrounding area, and replaced it.

The customer returned a short time later with an oil leak in the exact same place. This time the Technician cleaned the oil/residue and used leak trace powder to determine the source and identified the leak was from the oil pan seal, NOT the level switch. After resealing the oil pan the vehicle was fixed and no more leaks were found.

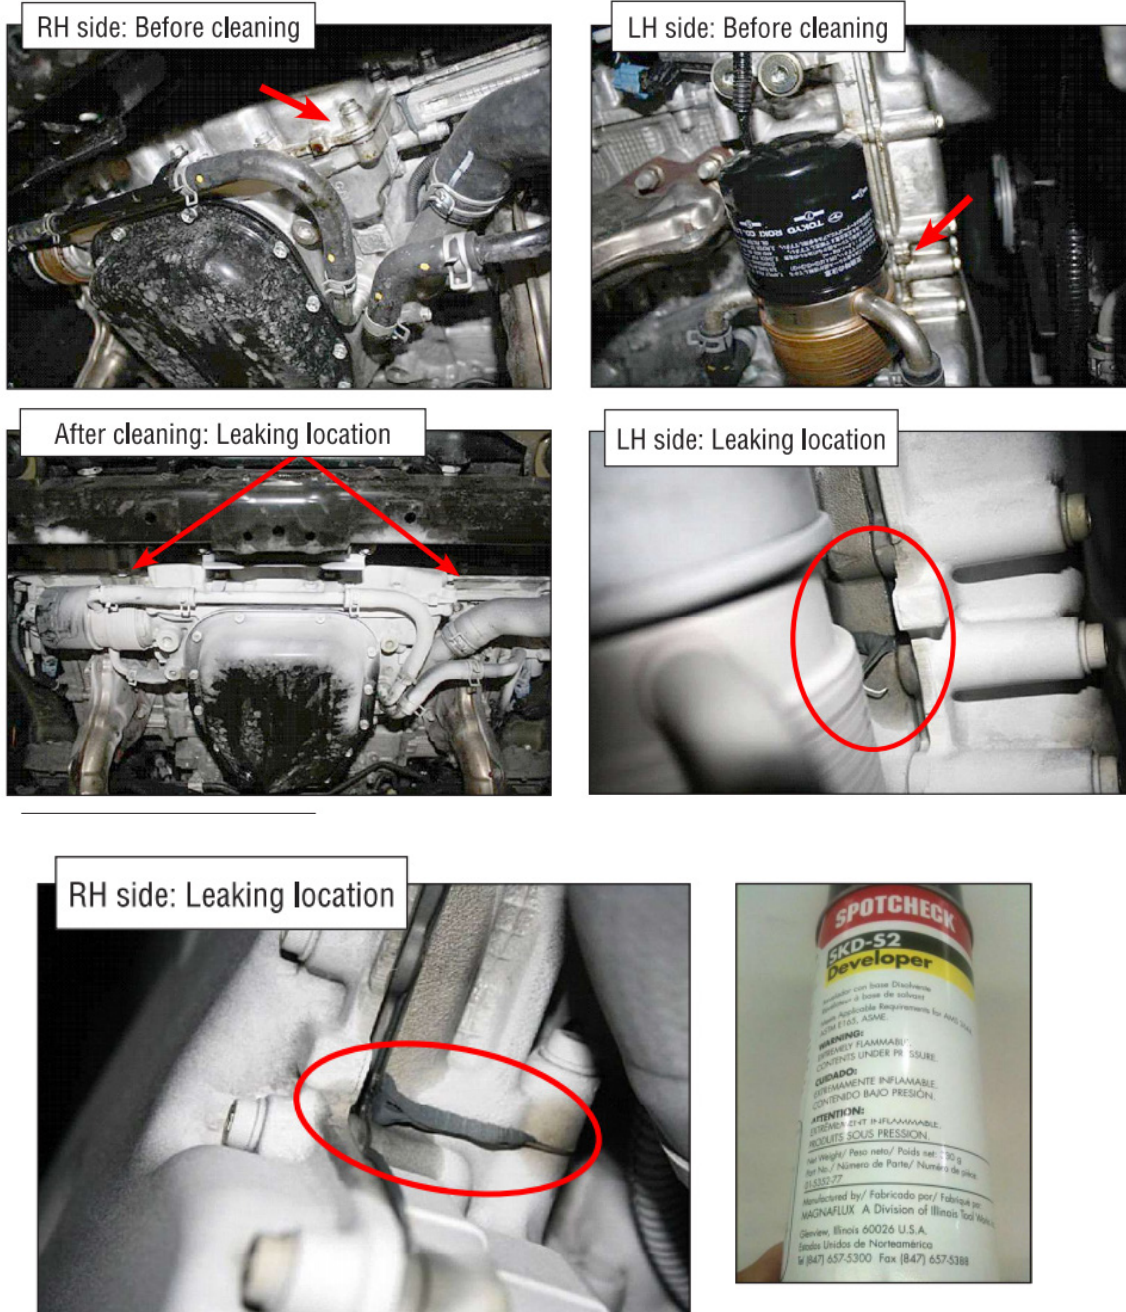
Here is another example. At first glance before cleaning, it appears the front timing cover is leaking. After cleaning and with the help of leak trace powder, it is properly identified that the head gaskets are leaking. This could have easily resulted in a costly shop comeback and a decline in customer satisfaction if misdiagnosed.

If Technicians are able to identify any leaks, SOA is requesting a QMR be submitted with photos of the leaking point, and where leak trace powder has been applied for clear origin confirmation as shown above. Be sure to take several pictures both up close and far away so location and orientation are clearly understood.

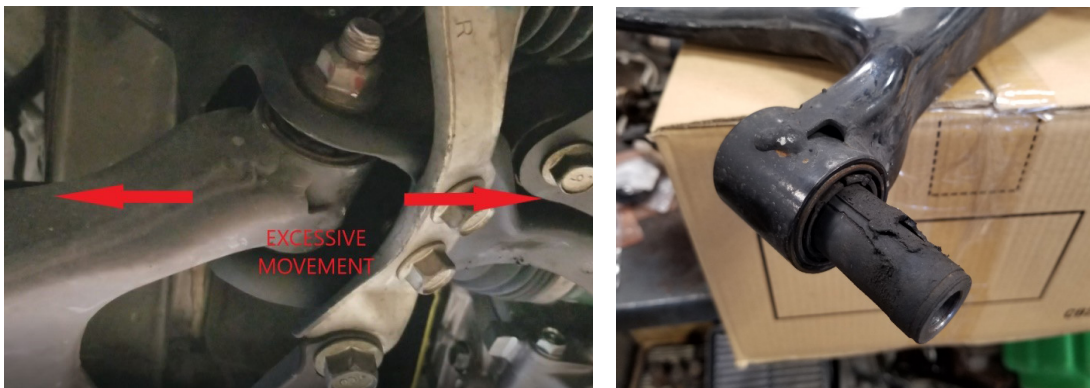
The Subaru Claims Department has identified a trend involving improper repair procedure. There are instances of retailers identifying bushings within the front lower control arm as the source of customer concern related to NVH or drivability, then replacing the entire control arm assembly. The proper repair involves replacing the failed bushing(s) by following the service manual procedures. There are few reasons that a claim should be made to Subaru to replace the entire arm instead of bushing replacement. Subaru Claims Policy does not allow for damages resulting from an impact, accident, environmental factors, and other reasons listed in our Policies and Procedures Manual found on Subarunet.

Failed bushing

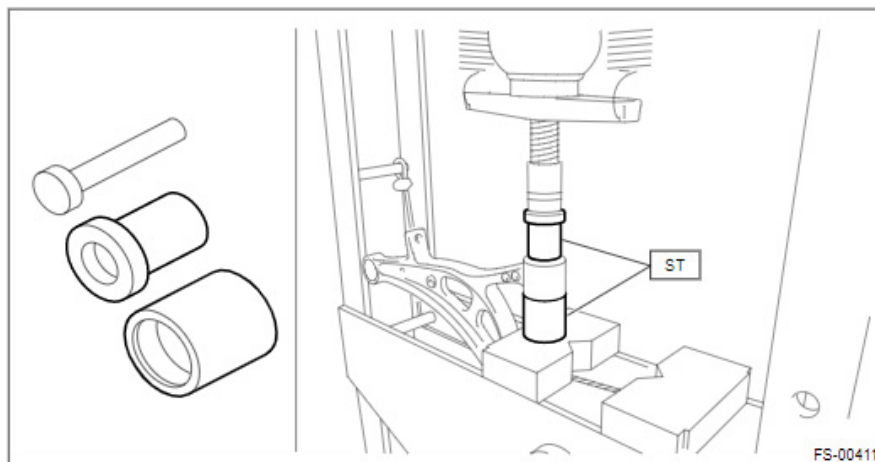
Bushing removal and installation procedure

Note: Review STIS for the proper removal and installation tool applicable to the model being repaired.
Suspension -> Front Suspension -> Disassembly/Reassembly, #2

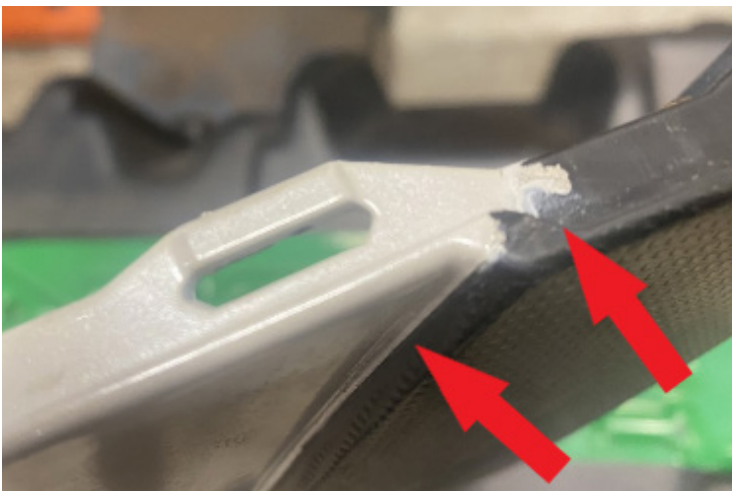
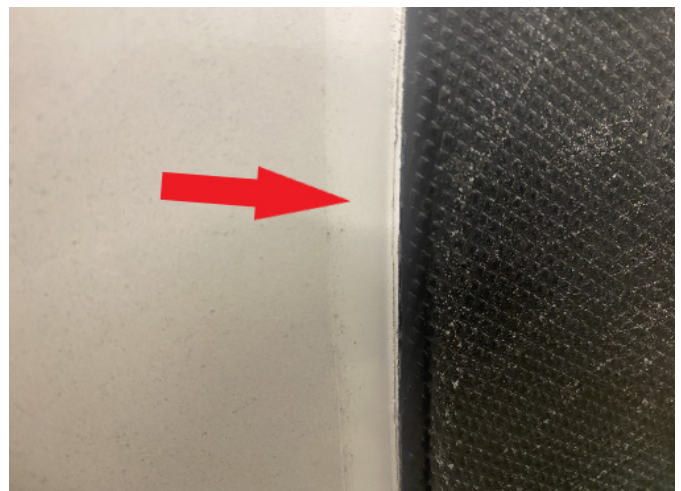
Evidence of body work includes poor paint coverage in corners, overspray, and tape lines.

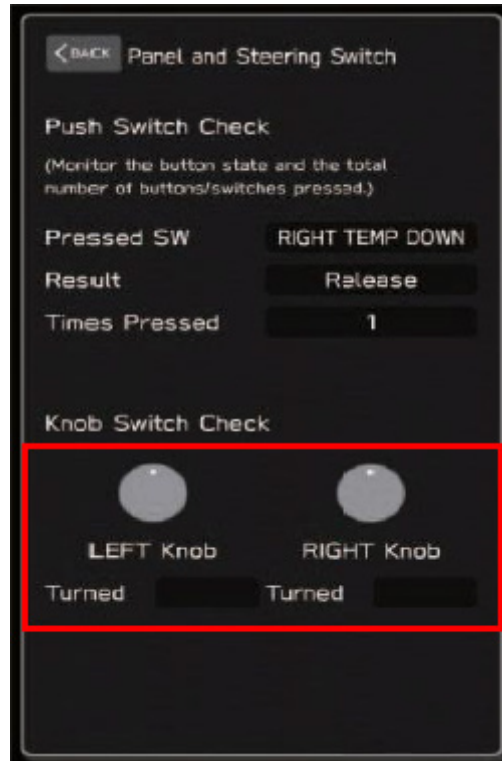
Technicians have reported when performing Panel and Steering Switch function check, using “VOLUME” and “TUNE” knobs/switches located on the CID, the count appearing in “Turned” seems to be out of sync with the knob rotation.

Be advised, this is normal operation. This behavior applies to both CID options 11.6” & 7”. The function’s purpose is to measure how many clicks are dialed in over a certain amount of time (1 sec), NOT accumulative dial counts. The number readout is directly linked to the speed of knob rotation. This function is set with the intention to confirm knob’s operability without malfunction. This test allows the Technician to know the direction of clicks (clockwise or counterclockwise) and its rotation speed (volume).
