# Service Information Letter

March 31, 2021

Units Affected: HD35A pressure diggers built from 2005 through 2020 (Verify that your unit serial number is affected by reviewing the attached list in this SIL or by accessing your fleet on [connect.altec.com/login](http://connect.altec.com/login))

## Stationary Frame Inspection

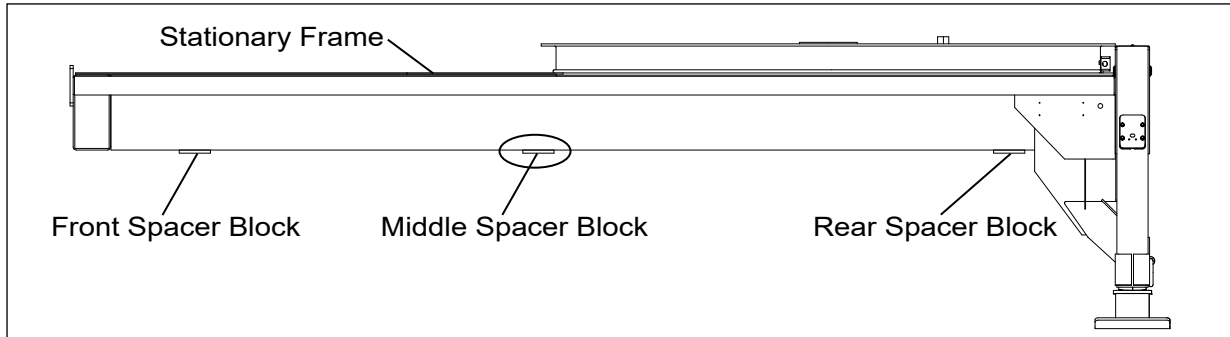
**Figure 1 – Spacer Block Location**

1. Position the unit on a level surface. Apply the parking brake and chock the wheels. Turn off the engine and remove the key from the ignition.
2. Find the middle spacer block that is welded to the bottom of the stationary frame tube on the street side of the unit near the rear axle (refer to Figure 1).

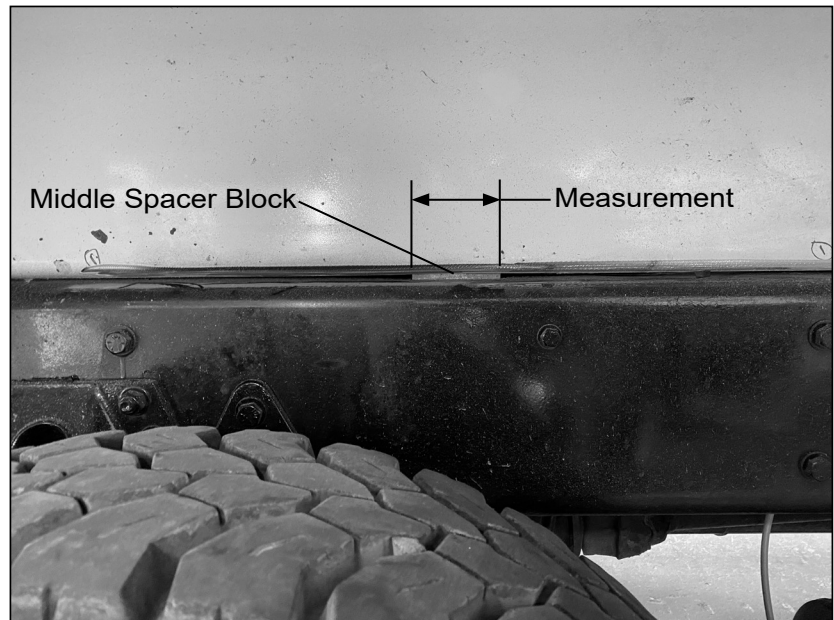
**Figure 2 – Spacer Block Measurement**

3. Measure the length of the middle spacer block on the street side from the front edge to the rear edge (refer to Figure 2). Repeat for the middle spacer block on the curb side.

4. Review the measurements.
  - If the measurement is 3” or 5” for both blocks, the blocks are oriented correctly and no repair is required. Return the unit to service. Complete the Evaluation Sheet at the end of the SIL.
  - If the measurement is 4” for one or both blocks, the block(s) are oriented incorrectly. Proceed to the Repair Procedure.

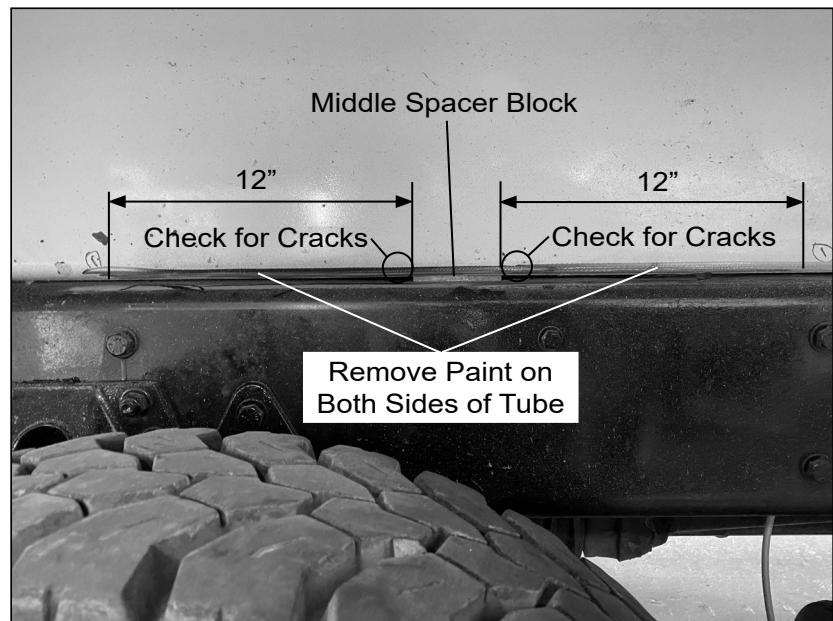
**Figure 3 – Removing Paint and Checking for Cracks**

3. Remove the paint from the bottom corners of the tube in an area 12" ahead of and 12" behind the middle stationary block on both sides of both stationary frame tubes (refer to Figure 3).

4. Inspect for any cracks near the spacer block on both sides of both tubes.

5. Drill a ¼" hole at the end of each crack.

6. Vee-grind a groove ⅛" deep x ¼" wide along each crack.

7. Use a sander to remove the paint about ½" beyond each side of the grooves.

8. Weld the grooves and the holes slightly above full, and sand the welds flush.
