Mack Chassis - Anthem (AN) And Pinnacle (PI) - ABS Modulator Wiring Rubbing Front Shock

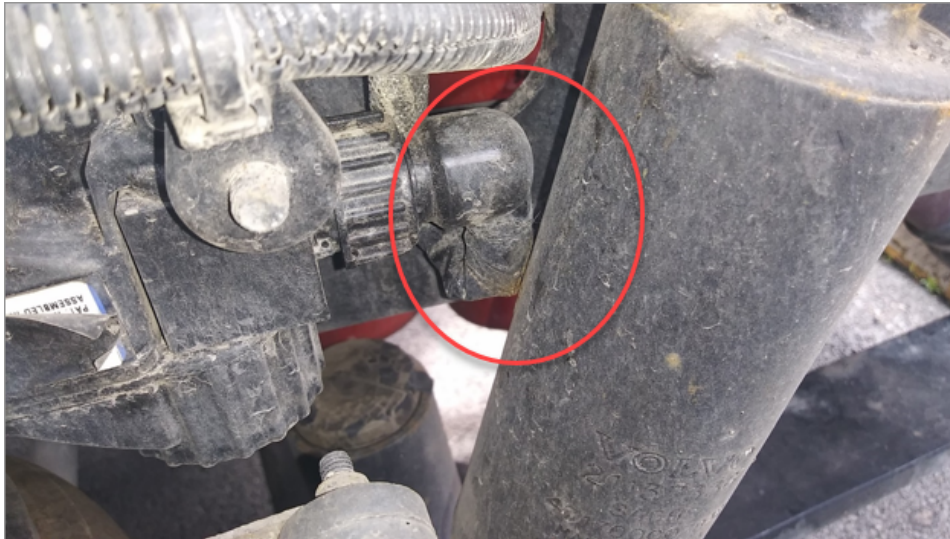
Some Mack Anthem and Pinnacle trucks built between January 29, 2018 and September 13, 2020, with Hendrickson air ride front suspension may have the ABS modulator valve wiring contact and rub the front shock.

A new pigtail connector is available to add clearance between the wiring and shock. Trucks built after September 13, 2020 have the modulator moved rearward away from the shock to prevent contact.

85130746 – Connector pigtail, 4 pin round, twist lock

21105899 – Butt splice for 18 GA/0.8 mm and 1.0 mm wire

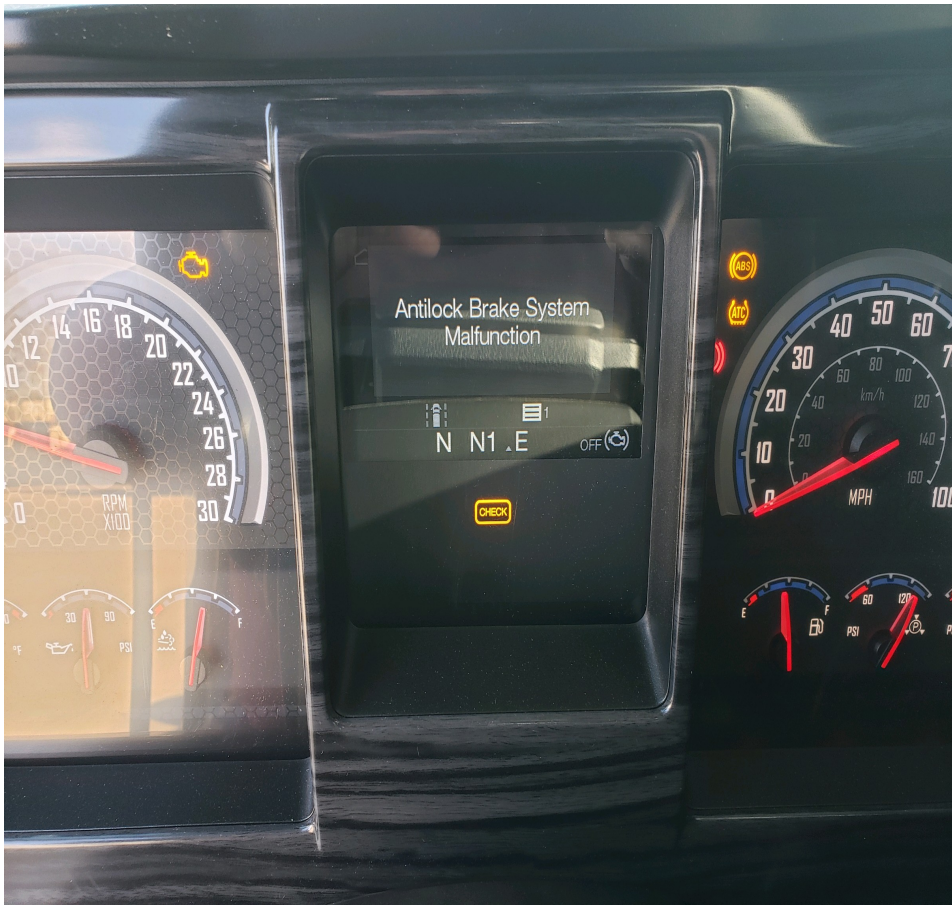
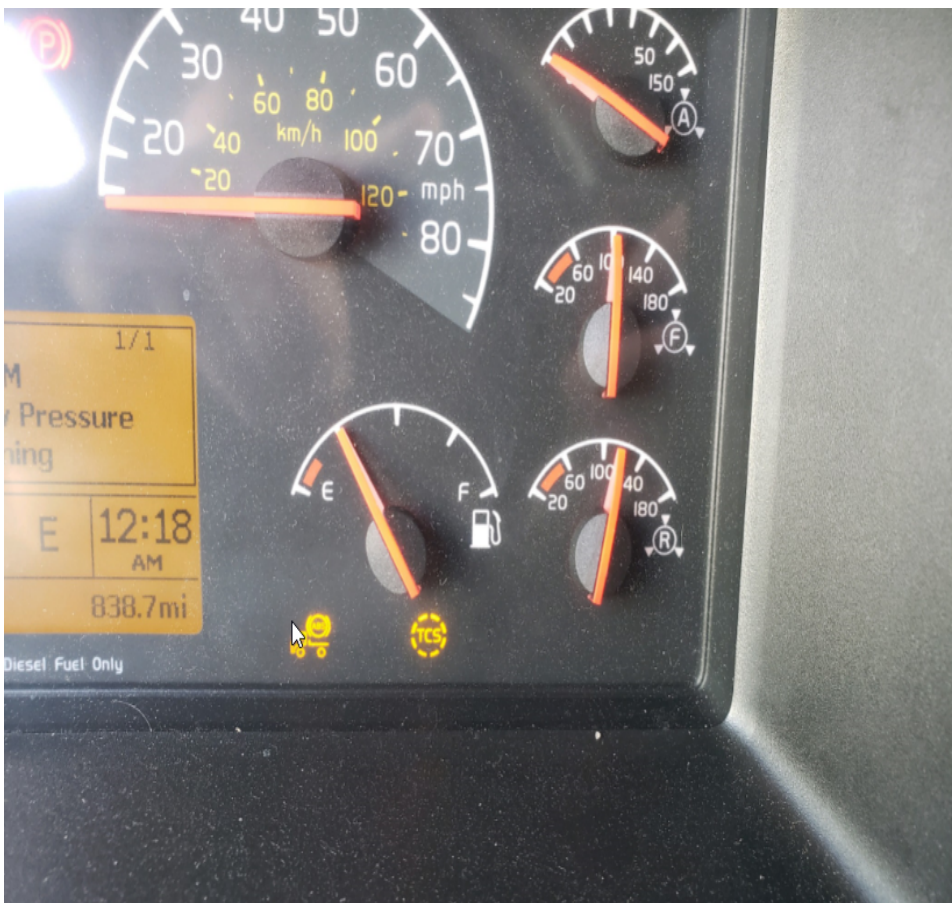
Wire contact and rubbing may result in open- or short-circuits and ABS fault codes. See images below.
