GROUP BOD	MODEL 2017MY Sorento (UMa)
NUMBER 169 (Rev 2, 6/14/2017)	DATE May 2017

## TECHNICAL SERVICE BULLETIN

SUBJECT: SERVICE ACTION: PANORAMIC SUNSHADE  
ROLLER GUIDE ADJUSTMENT (SA291A)

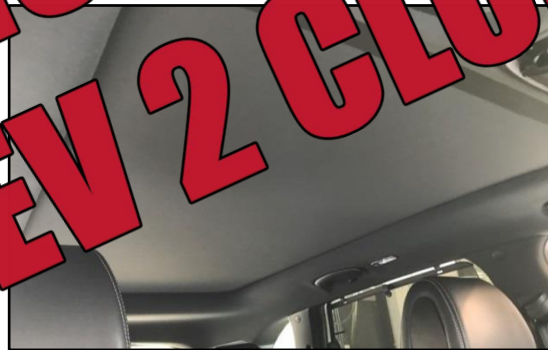
This bulletin provides the procedure to adjust the panoramic sunshade roller guide on some 2017MY Sorento (UMa) vehicles, produced from November 2, 2016 to February 3, 2017, which may experience a slow sunshade operation and noise when the sunshade is reaching the closed position. The concern is caused by interference of the sunshade to the roller guides. Follow the procedure outlined in this bulletin to adjust the sunshade roller guide. Sunroof assembly replacement parts are required to repair this concern. After conducting the procedure, verify that the vehicle is included in the list of affected vehicles.
