PRODUCT CAMPAIGN BULLETIN

APPLICABILITY: 2017-2019 MY Impreza
2018-2019 MY Crosstrek

NUMBER: WRE-21R

SUBJECT: Ignition Coil Replacement

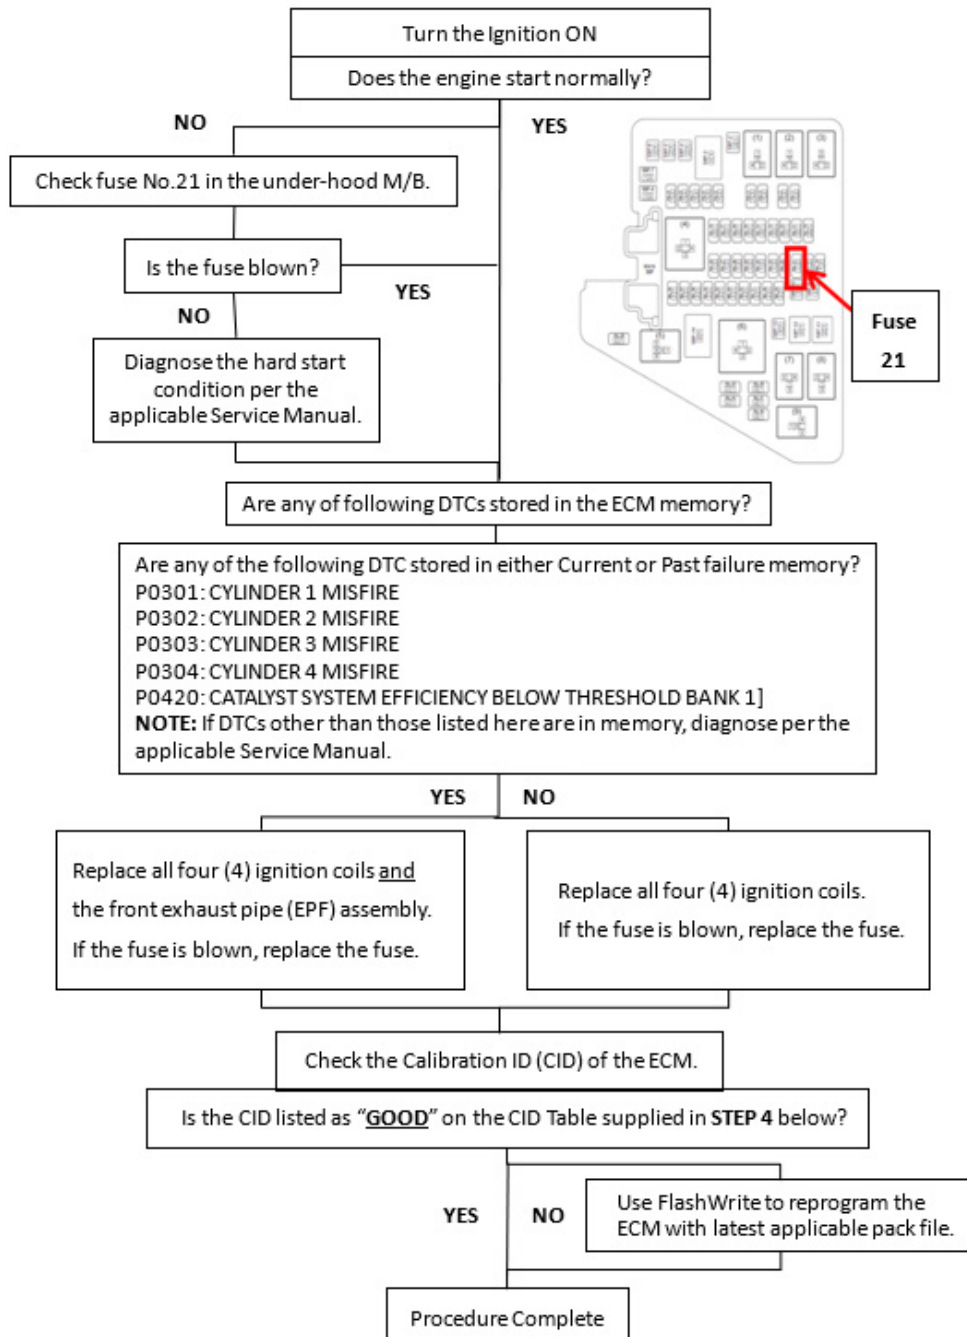
The following Flow Chart is provided as an overview of the procedures required to perform this Recall. A detailed Service Procedure is also supplied below.
