# Technical product information

<b>Topic</b>	Bentayga - Auxiliary tail lights in bumper operating instead of main tail lights when not intended
<b>Market area</b>	Russische Föderation (5RU),Australia E04 Bentley rest Asia and Australia (6E04),China 796 VW Import Comp. Ltd (Vico), Beijing (6796),Germany E02 Bentley rest Europe (6E02),Japan E03 Bentley Japan (6E03),Korea, (South) E08 Bentley South Korea (6E08),United Arab Emirates E06 Bentley Middle East and Africa (6E06),United Kingdom E01 Bentley UK (6E01),United States E05 Bentley USA and rest America (6E05)
<b>Brand</b>	Bentley
<b>Transaction No.</b>	2063070/1
<b>Level</b>	EH
<b>Status</b>	Approval
<b>Release date</b>

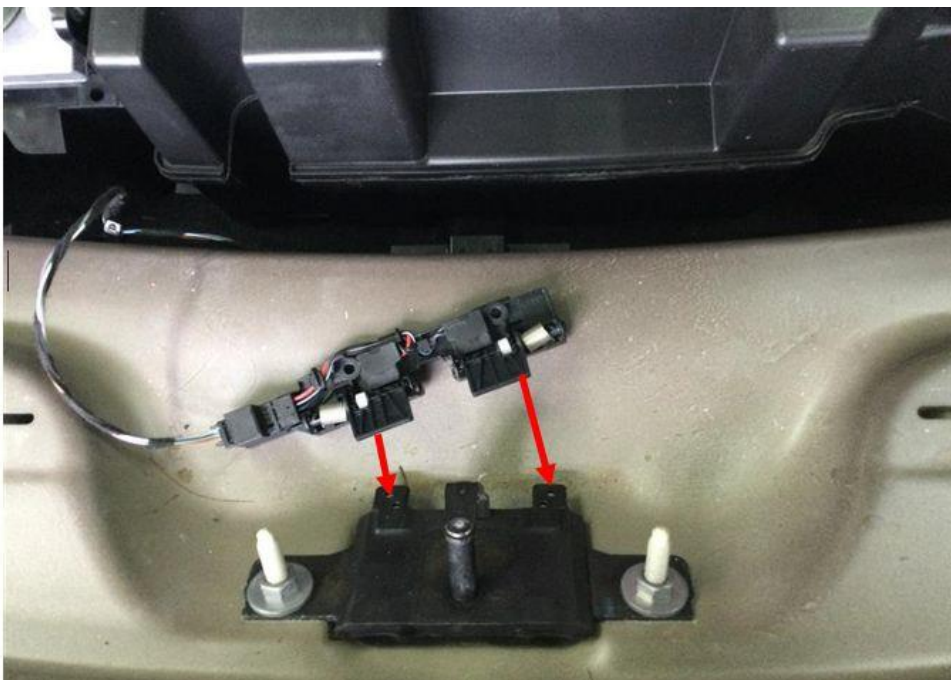
- Figure 2 - Shows a sensor which is not fixed correctly

In this case, fit the sensor to the latch as shown by the arrows

- Use x2 screws to secure into position
