Technical product information

Topic	HVAC operation issues/HVAC Motor defect DTC's logged
Market area	Bentley: worldwide (2WBE)
Brand	Bentley
Transaction No.	2051519/8
Level	EH
Status	Approval
Release date

HVAC operation issues and HVAC motor defect (DTC's) evident within address 08 – Climatronic control unit, the DTC's can be static or sporadic (Intermittent)

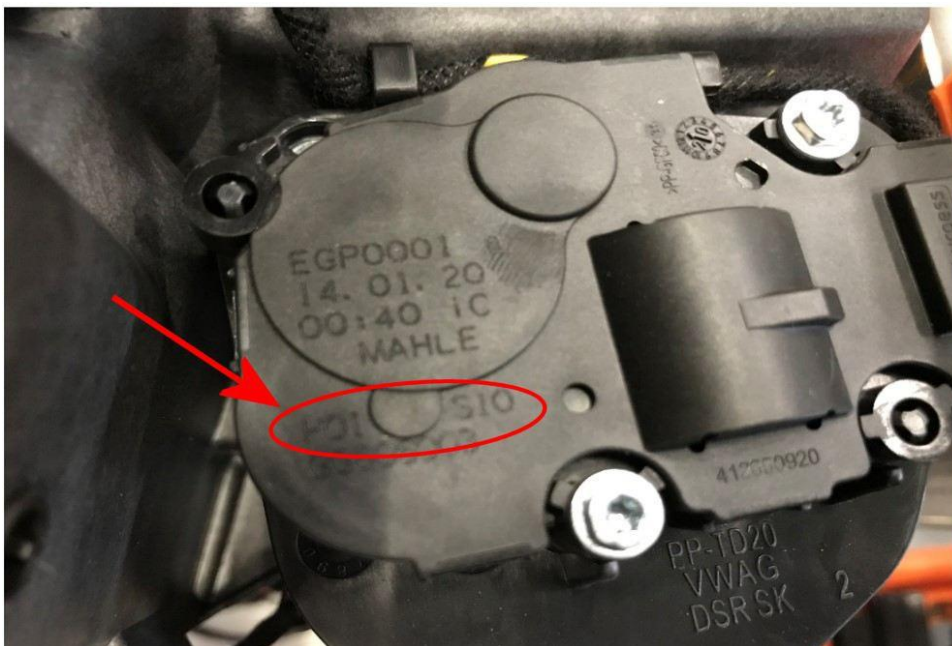
IMPORTANT NOTE: Referring to Figure 1 (Bentayga) and Figure 2 (New Continental GT/GTC and New Flying Spur) – In the event the Hardware level is H01 and the Software level is S10 these motors do not require replacement unless exhibiting an operational issue as these motors are the latest level

VERY IMPORTANT: To eliminate a repeat repair - The operative MUST replace all HVAC motors which are accessible with the afore listed components removed during the same operation/workshop visit regardless if the motors are faulty or not
