**Terex Utilities****PRODUCT NOTICE****PN689****DATE:** 4/14/2021**REVISED:****TO:** Owners, Users, Dealers, and Installers**MODELS AFFECTED:** TL80, TL80/112, & TL100**SUBJECT:** Leveling System**Issue:**

Terex Transmission TL models TL80, TL80/112, & TL100 aerial devices, produced from March 2019 through August 2020 may have unsatisfactory performance of the leveling system due to leveling cylinder bypassing. **Failure to correct the indicated issues may result in the platform not leveling properly.**

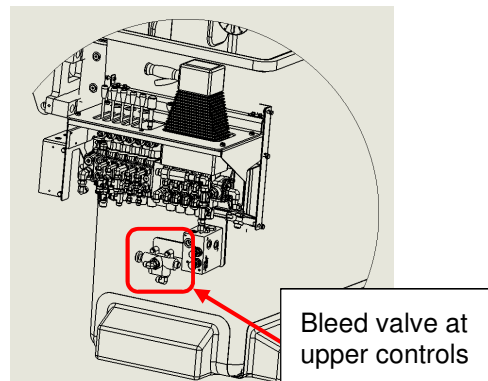
**Figure 1. Bleed kit with bleed valve at upper controls**

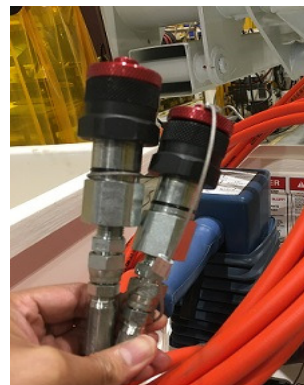
**Figure 2. Bleed kit with quick couplers at boom tip**

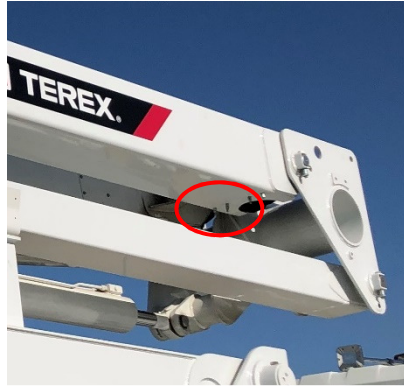
**Figure 3. Elbow leveling cylinder location**

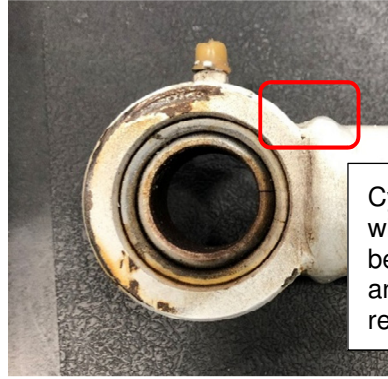
**Figure 4. Cylinder to be replaced**

Cylinder rod eye with weld hump between rod eye and rod to be replaced.

- Replacement elbow leveling cylinder (Field Service Kit Z1607) and boom-tip leveling cylinder (Field Service Kit Z1608)  
 Inspect elbow and boom-tip leveling cylinders to identify the leveling cylinder using the figures below. If both cylinders have the smooth weld transition from the rod eye to the rod, the cylinders do not need to be replaced.

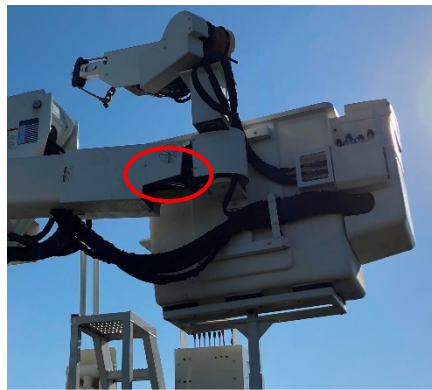
**Figure 5. Boom-tip leveling cylinder location**

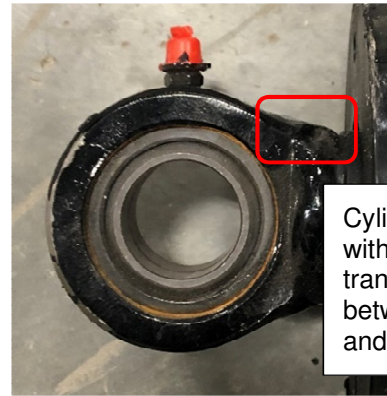
**Figure 6. Cylinder that is correct**

Cylinder rod eye with smooth weld transition between rod eye and rod is correct.

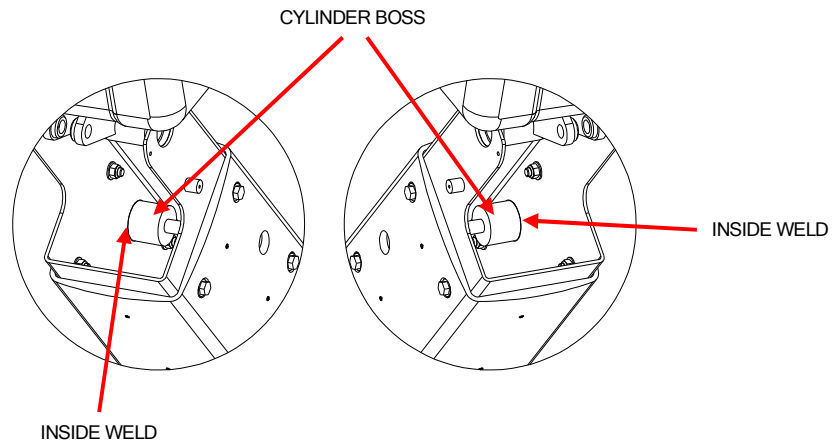
- Boom-tip leveling cylinder support boss inside weld – Field Service Kit Z1609  
 Some boom-tip leveling cylinder support bosses may not have been welded on the inside of the boom.

**Figure 7. If the boom-tip leveling cylinder support bosses are not welded on the inside as shown, this bulletin applies**

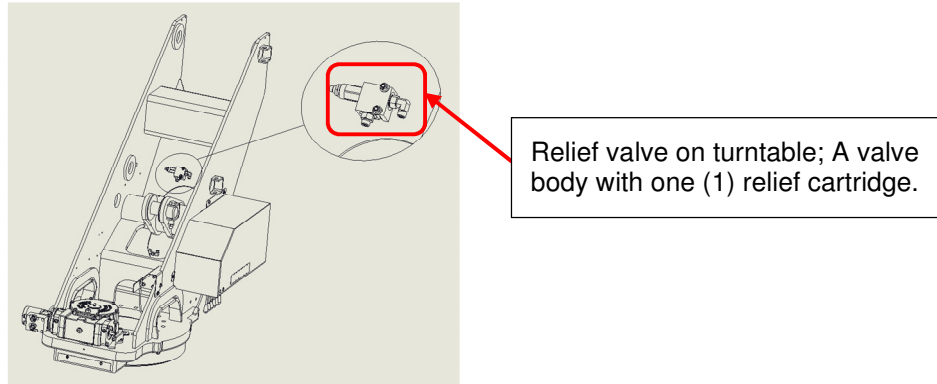
- Addition of a relief for the isolation valve – Field Service Kit Z1611  
The isolation relief valve for the leveling circuit is being added to protect the elbow leveling cylinder from damage in case the operator functions boom controls while also using the manual leveling control.

**Figure 8. If the valve shown is present, this bulletin may not apply**
