Terex Utilities**PRODUCT NOTICE****PN690****DATE:** 4/14/2021**REVISED:****TO:** Owners, Users, Dealers, and Installers**MODELS AFFECTED:** TL80, TL80/112, TL100**SUBJECT:** Transmission TL Updates**Issue:**

Terex Transmission TL models TL80, TL80/112, and TL100 aerial devices, produced from March 2019 through August 2020, should be upgraded to current production status. There have been several running changes and improvements including: boom tie down, jib transport position, and potential for leaking control valves. **Failure to correct the indicated issues may result in leaking hydraulic fluid at the control valves and damaged components during road travel.**

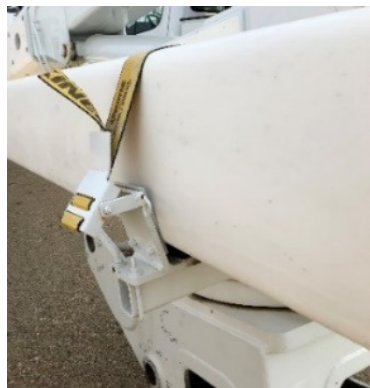
Figure 1. Cam style strap, this update applies

- a. Ratchet style versus cam over style upper boom hold down (TL80/112 only) – Field Service Kit Z1571
The ratchet strap is now recommended for securing the upper boom.

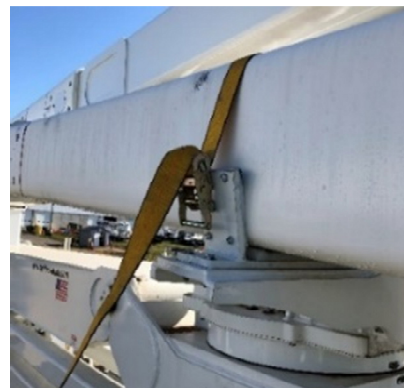
Figure 2. Ratchet style strap, this update may not apply

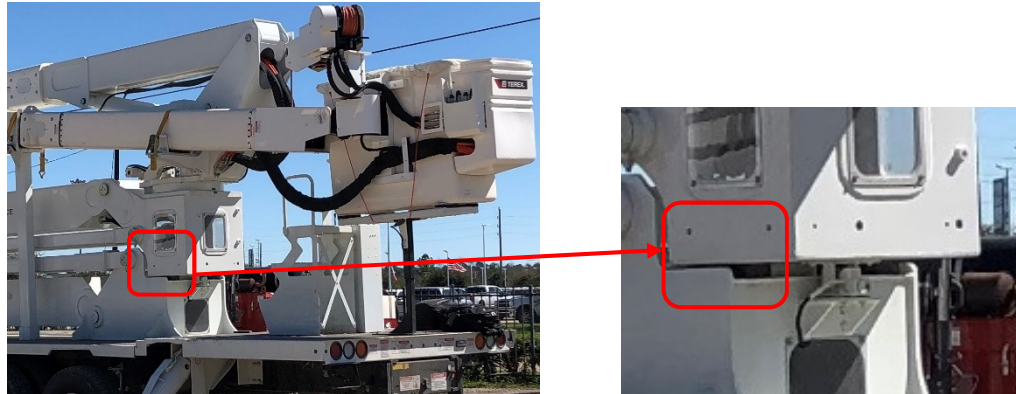
Figure 3. Elevator pedestal side support not installed, this update applies

- b. Added elevator pedestal side support (TL80/112 only) – Field Service Kit Z1571
The elevator side supports aid guiding the boom into the latch when stowing the machine when the truck is not level.

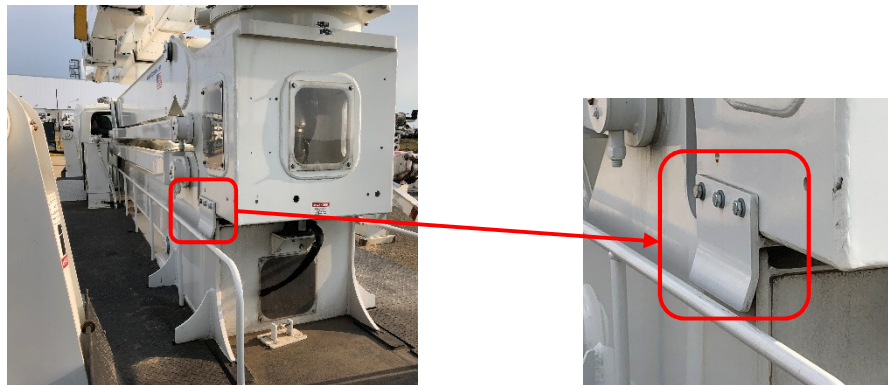
Figure 4. Elevator pedestal side support installed, this update may not apply

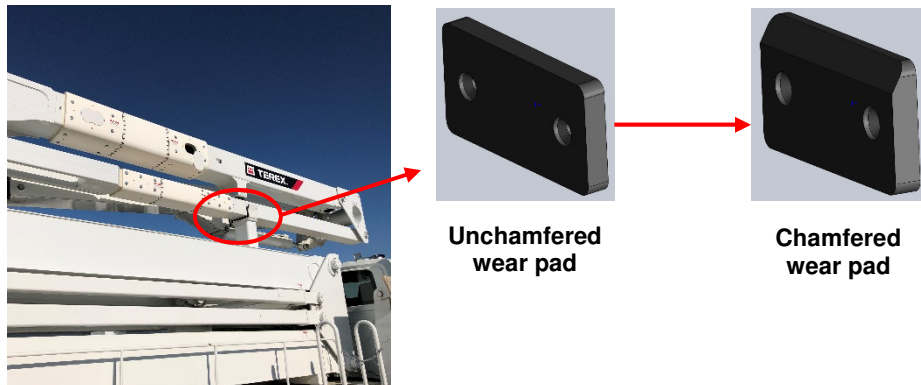
- c. Lower boom rest wear pads with chamfered edge (TL80/112 only) – Field Service Kit Z1586
Unchamfered wear pads can be damaged when lower boom is stored if the lower boom is not aligned with the rest. The chamfered pads help guide the lower boom into position.

Figure 5. If the upper wear pads for the lower boom rest are unchamfered, this update applies. If the upper wear pads are chamfered, this update may not apply.

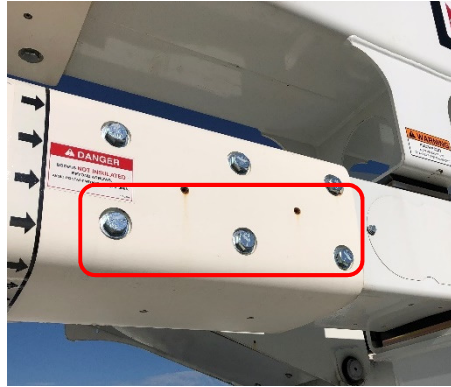
- d. Bolts for compensation link changed from hex head to button head (TL80 & TL100 only)
– Field Service Kit Z1596
If the location of the lower boom rest falls in the highlighted area, the bolts should be changed to button head bolts as the hex head bolts can damage the wear pad. This only applies to the TL80 and TL100; it does not apply to the TL80/112 units with a hydraulic lift.

Figure 6. If the compensator link lower bolts are hex head, this update applies

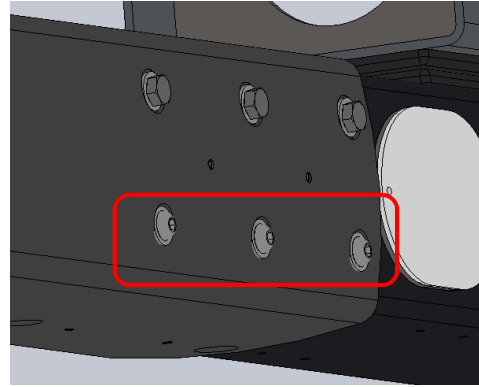
Figure 7. If the compensator link lower bolts are button head, this update may not apply

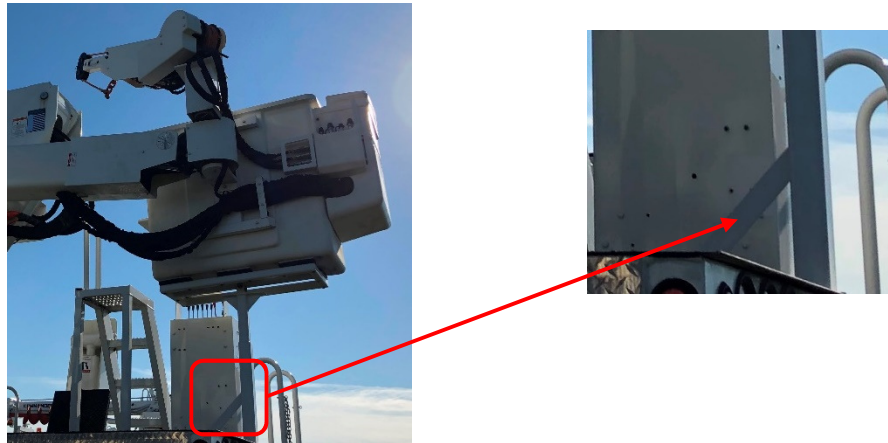
Figure 8. Basket rest reinforcement installed, this update may not apply

- e. Basket rest reinforcement – Field Service Kit Z1571 (TL80/112) or Field Service Kit Z1573 (TL80 & TL100)

A reinforcement is added to the basket rest support to stiffen the support tube.

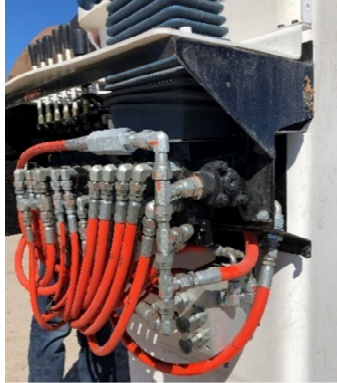
Figure 9. Upper control valve extra return line and vent not added, this update applies

- a. Hydraulic leaks from the upper and lower control valves
- b. Additional return line and atmospheric vent at upper control valve (TL80, TL80/112, TL100) – Field Service Kit Z1583

In order to reduce backpressure and potential related hydraulic leaks, an additional return line and atmospheric vent is added to the upper control valve.

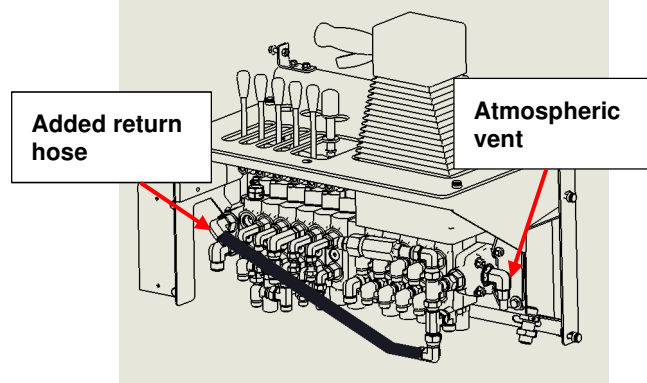
Figure 10. Upper control valve extra return line and vent added, this update may not apply

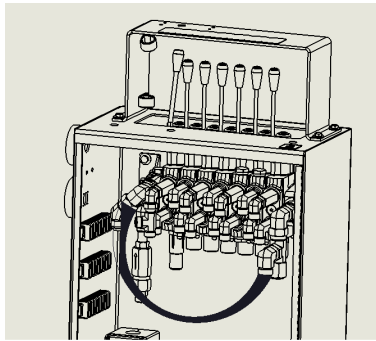
Figure 11. TL80/112 Control Valve. If the hose shown is present, this update may not apply

- c. Additional return line at the lower control valve (TL80, TL80/112, TL100) – Field Service Kit Z1583

In order to reduce backpressure and potential related hydraulic leaks, an additional return line is added to the lower control valve.

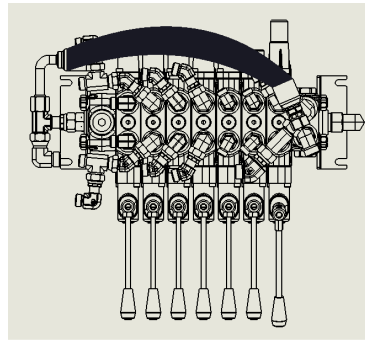
Figure 12. TL80 & TL100 Control Valve. If the hose shown is present, this update may not apply

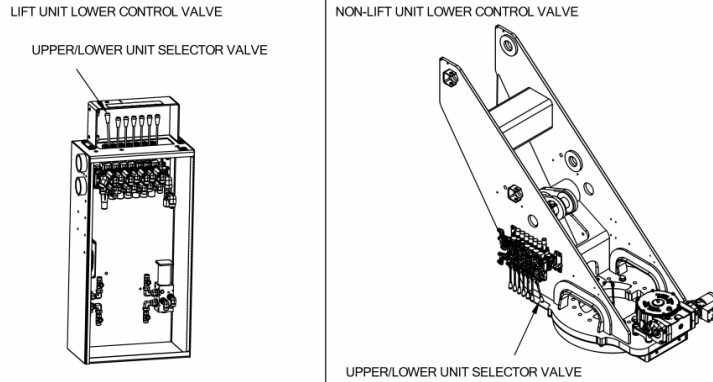
**Figure 13. Location of lower/upper selector control valve section.
If the seals haven't been replaced this update may apply.**

- d. Replacement lower/upper selector section seals (TL80, TL80/112, TL100) – Field Service Kit Z1610

A design improvement was made to replace the o-ring seals with quad ring seals to reduce leaks from the control valves.

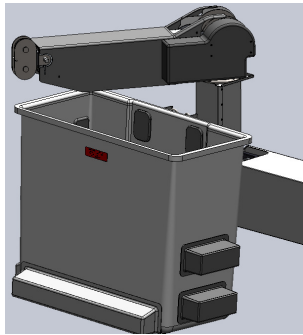
Figure 14. Jib can store over rear corner of platform, this update applies

- a. Jib storage change makes it easier to access the controls– Field Service Kit Z1571 (TL80/112) or Field Service Kit Z1573 (TL80 & TL100)

The rearmost jib storage position is plugged as it does not allow easy control access in that position. An additional jib storage position is added to allow the jib to store more in-line with the upper boom, allowing for easier control access and platform entry.

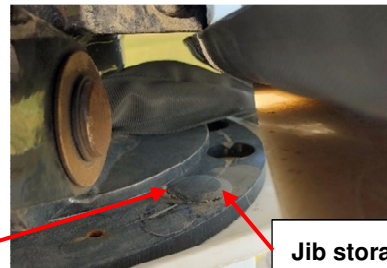
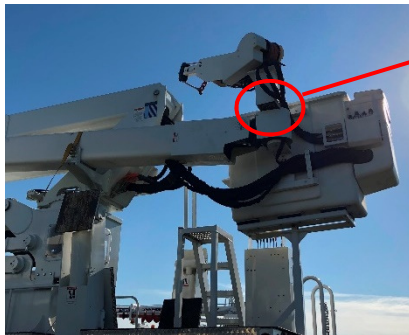
Figure 15. Jib storage limited to eliminate over rear position, this update may not apply

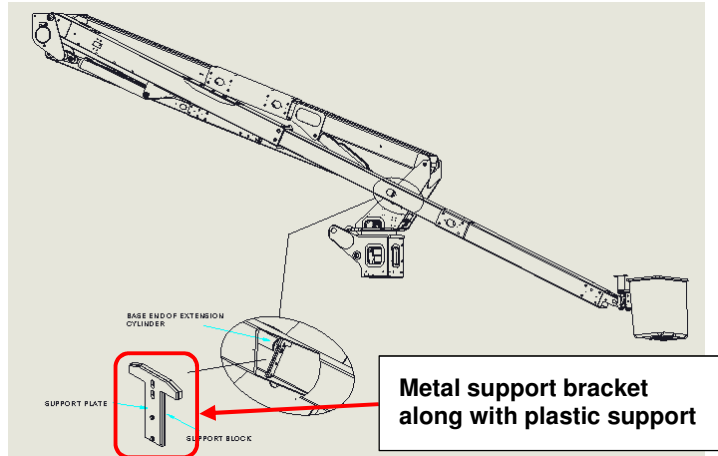
Figure 16. If the metal support shown is present, this update may not apply

- a. Addition of metal support bracket for the end of the extension cylinder (TL80, TL80/112, TL100) – Field Service Kit Z1606
A metal support is added to aid in properly supporting the cylinder.
