**Symptom in Vehicle Interior - Water Noise (Sloshing) During Acceleration/Braking or Water Leaking Into Rear Footwell (SY 224/20)**

Model Line: **Taycan (Y1A)**

Concerns: **Water drains on the high-voltage battery protective plate**

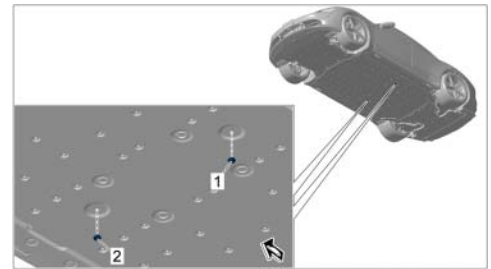
*Water drain on protective plate*

Cause: Dirt particles can cause the water drains on the high-voltage battery protective plate to become blocked and result in water not draining away.

- Work Procedure: 1 Raise the vehicle, see ⇒ *Workshop Manual '4X00IN Lifting the vehicle'*.
- 2 Remove both water drains ⇒ *Water drain on protective plate -1-* and ⇒ *Water drain on protective plate -2-* from the high-voltage battery protective plate using a suitable tool.
