Y1A Taycan

On Board Charger (OBC) Fault P31D200 “Charging Socket – Overtemperature”

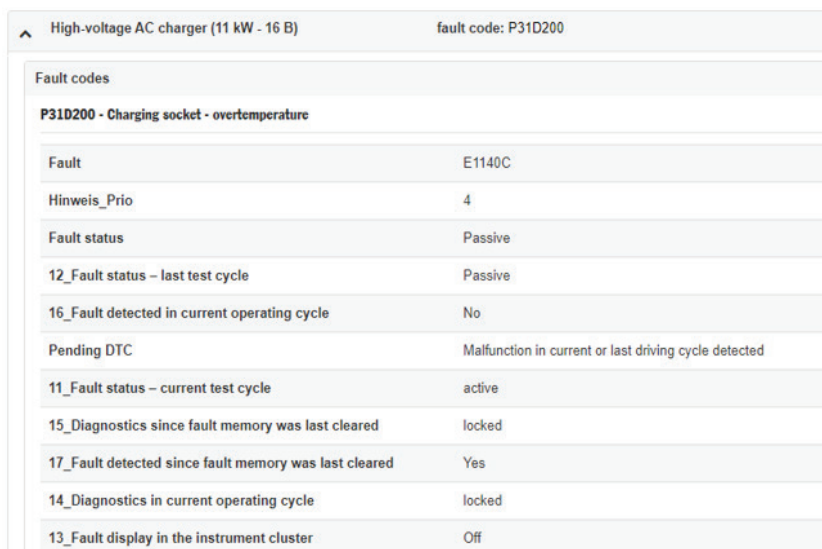
Figure 1

The customer reports that the vehicle intermittently stops charging while using the Porsche Mobile Charger Connect and associated cables. The workshop is able to confirm this condition using the customer's charging hardware, and the On Board Charger (OBC) has stored fault code P31D200 “Charging socket – overtemperature”.

High-voltage AC charger (11 kW - 16 B)		fault code: P31D200
Fault codes		
P31D200 - Charging socket - overtemperature		
Fault	E1140C	
Hinweis_Prio	4	
Fault status	Passive	
12_Fault status – last test cycle	Passive	
16_Fault detected in current operating cycle	No	
Pending DTC	Malfunction in current or last driving cycle detected	
11_Fault status – current test cycle	active	
15_Diagnostics since fault memory was last cleared	locked	
17_Fault detected since fault memory was last cleared	Yes	
14_Diagnostics in current operating cycle	locked	
13_Fault display in the instrument cluster	Off
