40/21 ENU 4381

Complaint – Warning Message "Lift System Fault – Service Necessary" Appears in Instrument Cluster: Observe Specified Procedure (40/21)

Model Line: 911 Carrera (992)

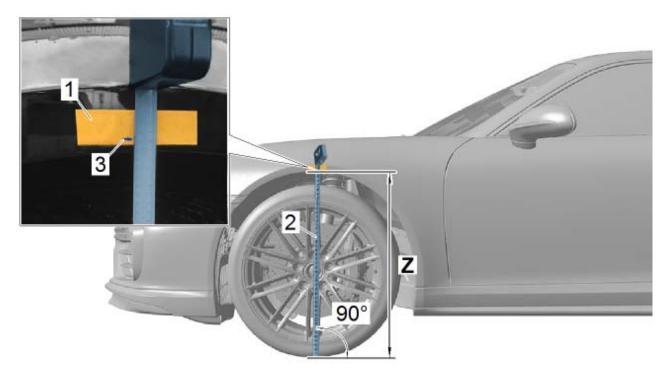
Ride height measurement, front left

- 1.2 Determine the ride height at the front left \Rightarrow *Ride height measurement, front left-Z-*.
 - 1.2.1 Apply adhesive strips (e.g. adhesive tape) \Rightarrow *Ride height measurement, front left* -1- to the wing.
 - 1.2.2 Align the measurement tool \Rightarrow *Ride height measurement, front left* **-2** vertically and mark the measuring point \Rightarrow *Ride height measurement, front left* **-3**-.
 - 1.2.3 Carefully measure the ride height and write it down.
 - 1.2.4 Repeat the procedure for the right side.
- 1.3 Observe an idle period of three hours.
- 1.4 Repeat the measurements, write them down and compare values:

Assessment	Action required
(√)	The ride height at the left or right has dropped by less than 10 mm (0.4 inch).	Please inform the customer that the vehicle must only be parked with the front body section lowered. Further information can be found in the 'Front-axle lift system' section of the Owner's Manual. There is not necessarily a technical fault if the fault type occurs again. The error message can be corrected by repeated raising and lowering of the lift system.
(X)	The ride height at the left or right has dropped by more than 10 mm (0.4 inch).	Replace compressor for front-axle lift system, see \Rightarrow Workshop Manual '431519 Removing and installing compressor (front-axle lift system)'.
