991 – Clicking Noises from Centerlock Wheels

Vehicles Affected

Models	Model Year	Model Type	VIN Range	Vehicle-Specific Equipment
911 Carrera GTS, Turbo, Turbo S, GT3, GT3RS, GT2RS, Speedster	As of 2014 up to 2019	991	N/A	Centerlock wheel nuts, aluminum alloy wheels, and PCCB brake discs

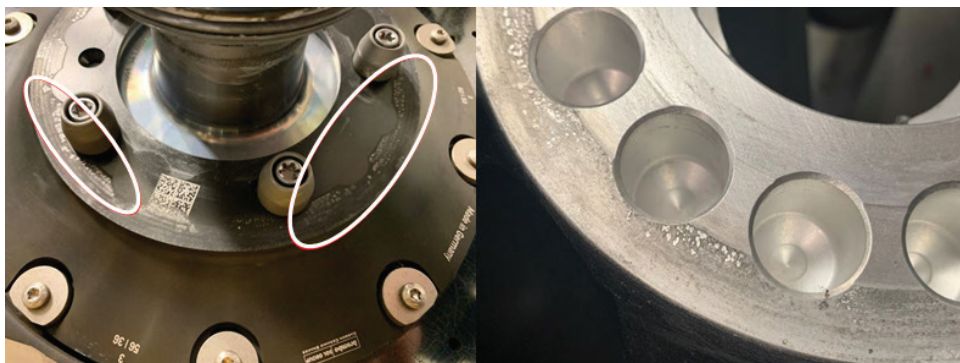
The wheels may experience "micro-movements" at the interface with the brake disc bell during driving. Micro-movements may be caused by an insufficient pretension of the centerlock nut, reduced friction values between multiple contact surfaces, or geometrical discrepancies between parts.

These micro-movements may cause material to be transferred from the aluminum alloy wheels to the brake disc bell. The transferred material may cold-weld to the brake disc bell, causing a "stick-slip" effect. The stick-slip effect produces clicking noises while turning.

Figure 2
Material Transfer to Brake Disc Bell (Left) from Wheel (Right)

3. Inspect the outer surface of the brake disc bell and the inner surface of the wheel that contacts the brake disc bell. If any material transfer or corrosion is present on either surface (Figure 2), gently and thoroughly clean the surface of both parts. Document any material transfer and corrosion with pictures.

- a. To clean the surfaces, please use special tool **VAS 294009 – Wheel Hub Cleaner**.
 - i. **Only if special tool VAS 294009 is unavailable**, 3M Scotch-Brite Hand Pads 7445 (white) and 7448 (light gray) may also be used.

1. Begin by gently cleaning with pad 7445. If pad 7445 does not completely remove all corrosion and material transfer from the surfaces, gently clean the surfaces with pad 7448.

- b. If a surface cannot successfully be cleaned, replace **only** the component that cannot be cleaned.
 - i. If no parts are replaced, or if only the wheel is replaced, or if only the brake disc is replaced, continue to Step 4.
 - ii. If both the wheel and brake disc are replaced, skip to Step 6.

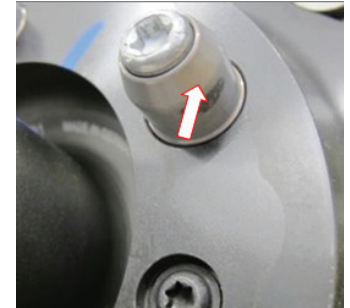
Figure 3
Material Transfer on Drive Peg

4. Inspect for material transfer on the contact surfaces between the drive pegs and brake disc (Figure 3).
Replace the drive pegs **and all drive peg screws** if material transfer is present. Document any material transfer with pictures.

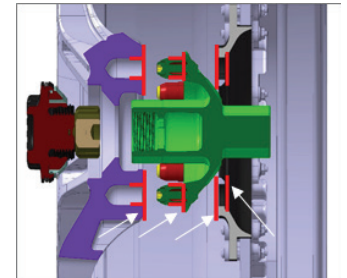
Figure 4
Mating Surfaces to Check for
Anti-Corrosion Oil

6. If any anti-corrosion oil is present from manufacturing on any mating surfaces (marked in red with white arrows in Figure 4), on new or old parts, clean the parts with a microfiber cloth and brake parts cleaner. Document presence of anti-corrosion oil with pictures.
