MODEL  
2020MY  
Rio (SC) w/IVT

NUMBER  
097

DATE  
May 2021

SUBJECT: **SERVICE ACTION: IVT/CVT SW LOGIC IMPROVEMENT  
AND/OR IVT/CVT REPLACEMENT (SA476)**

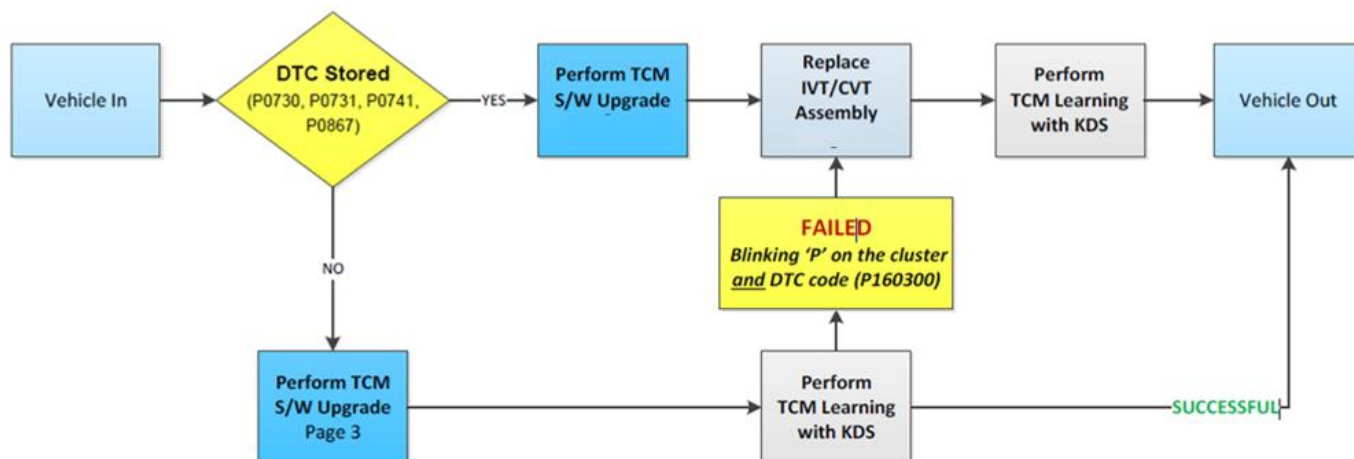
### Flowchart:

- **P0730** – Incorrect Gear Ratio
- **P0731** – Gear 1 Incorrect Ratio
- **P0741** – Torque Converter Clutch Circuit Performance or Stuck Off
- **P0867** – Transmission fluid pressure

- **P160300** – P-Learning Fail (CVT System)

- 1) Using the KDS (connected to the internet to create and transmit a VDN\*), perform a Fault Code Search and confirm DTC P0730, P0731, P0741 or P0867 is/are stored (Active, History or Pending). Follow the flow chart above and perform the necessary procedure(s).

- 2) If one of the four DTCs (P0730, P0731, P0741, P0867) applies during the DTC Check, upgrade the TCM S/W and replace the IVT/CVT.
- 3) Replace the IVT/CVT according to the applicable Shop Manual on KGIS.

- 4) Then perform the IVT/CVT resetting auto T/A values, oil-pressure characteristics input, TCM adaptive values learning procedure.
- 5) If DTCs P0730, P0731, P0741, and P0867 do not come back, upgrade the TCM S/W and perform TCM adaptive values learning procedure. If successful, complete the service. If not, and TCM Learning fails, 'P' will be blinking on instrument cluster and DTC code P160300 will set. Then replace the IVT/CVT and do TCM Learning again.
