**Symptom - Engine - Knocking, Jerking or Vibrations During Acceleration: Checking Fuel Injectors (SY 41/21)**

Model Line: **Cayenne (9YA)  
Cayenne Coupé (9YB)**

Model Year: **As of 2018**

Concerns: **Fuel injector**

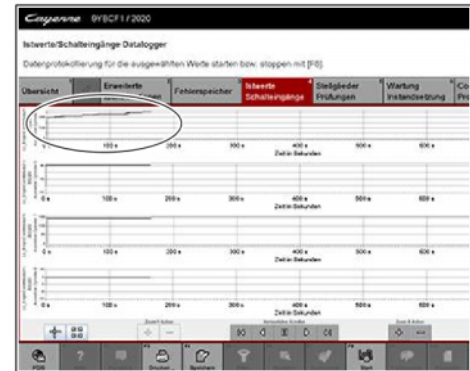
- 5 Look at the log and check the cylinder misfire counter during acceleration. ⇒ *Misfires per cylinder*

Result of check		Action required
(✓)	There is <b>no</b> increase in misfiring on a cylinder.	<b>End of action required.</b> Fuel injectors and ignition system OK.
(✗)	There is increased misfiring on a cylinder.	<b>Continue with Step 6.</b>
