HYUNDAI Technical Service Bulletin

GROUP Campaign	NUMBER 21-01-026H
DATE April 2021	MODEL(S) Venue (QX)

SUBJECT: MDPS ECU UPDATE FOR DTC C125901 AND C111201
(SERVICE CAMPAIGN T6D)

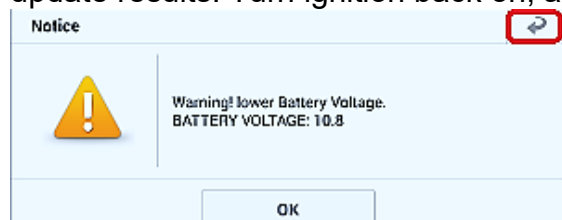
GDS Vehicle Battery Voltage Warning:

If voltage is below 12 volts as per the below GDS warning, then select **Back** and run the vehicle for at least 20 minutes to ensure an adequate battery state of charge for reliable update results. Turn ignition back on, and then retry the ECU update again.
