HYUNDAI Technical Service Bulletin	GROUP BODY ELECTRICAL	NUMBER 21-BE-007H
	DATE APRIL, 2021	MODEL(S) ELANTRA (CN7a)
SUBJECT: REAR COMBINATION LAMP TURN SIGNAL BULBS REPLACEMENT

SUBJECT: REAR COMBINATION LAMP TURN SIGNAL BULBS REPLACEMENT

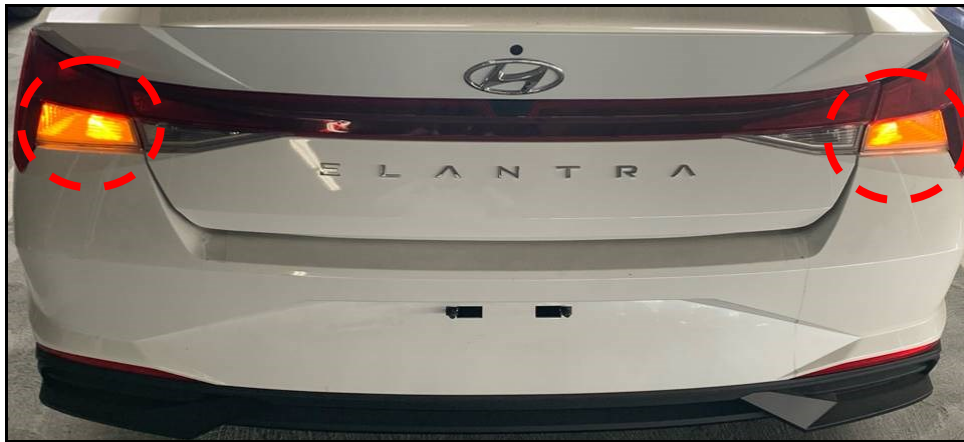
Description: Some 2021 Elantra (CN7a) rear combination lamp turn signal light bulbs may prematurely become inoperative. This bulletin describes the procedure to replace the rear combination lamp turn signal light bulbs for both the right and left side.
