# Technical product information

<b>Topic</b>	New Continental GT, GTC, New Flying Spur - Blind spot monitors not functional DTC C1114F3 logged in address 003C or 00CF
<b>Market area</b>	Russische Föderation (5RU),Australia E04 Bentley rest Asia and Australia (6E04),China 796 VW Import Comp. Ltd (Vico), Beijing (6796),Germany E02 Bentley rest Europe (6E02),Japan E03 Bentley Japan (6E03),Korea, (South) E08 Bentley South Korea (6E08),United Arab Emirates E06 Bentley Middle East and Africa (6E06),United Kingdom E01 Bentley UK (6E01),United States E05 Bentley USA and rest America (6E05)
<b>Brand</b>	Bentley
<b>Transaction No.</b>	2062884/1
<b>Level</b>	EH
<b>Status</b>	Approval
<b>Release date</b>

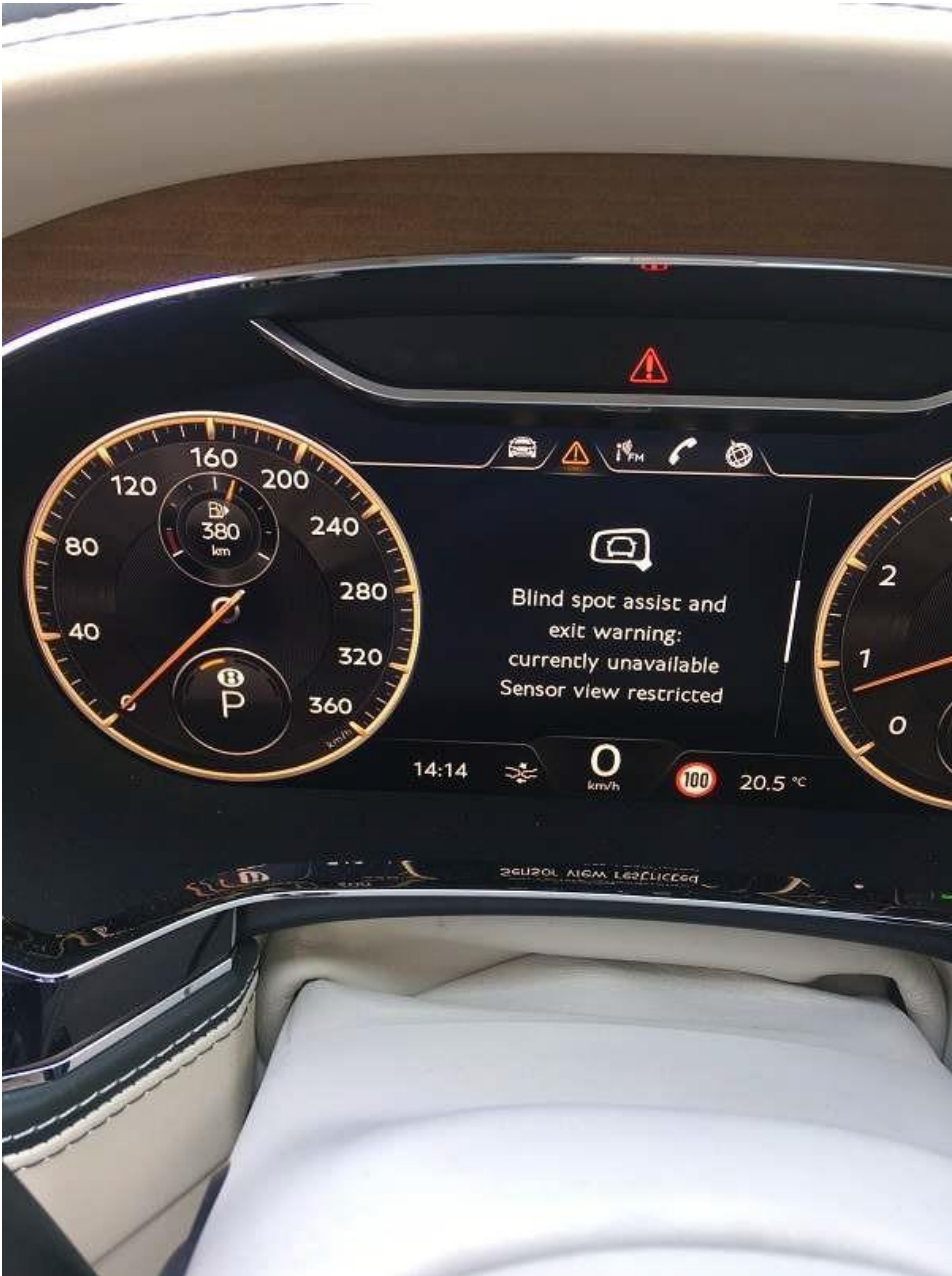
Figure 1

Blind spot monitors (Wing mirror illuminations) are not functional in conjunction with sporadic Bentley assist warnings present in the DIP (Figure 1)

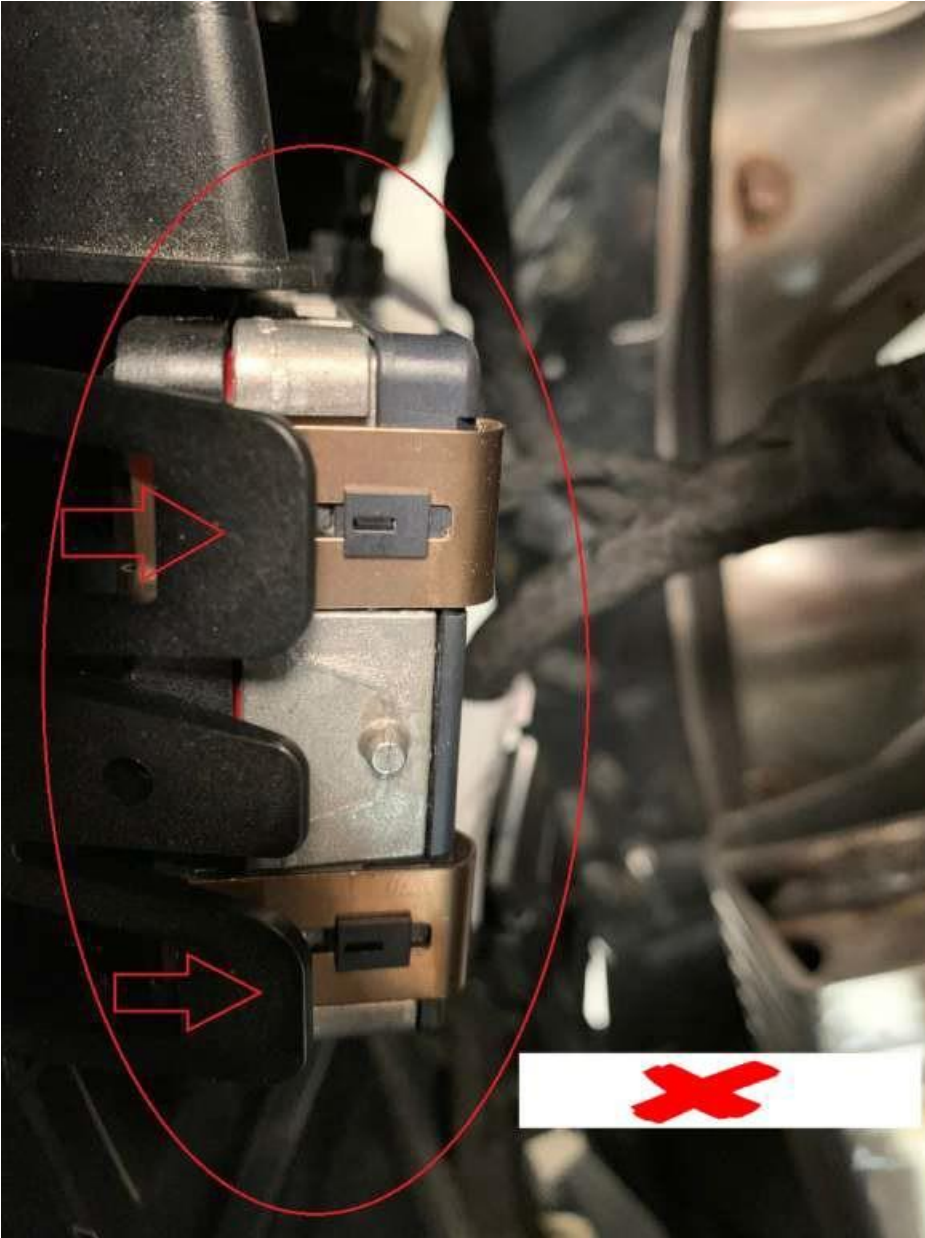
Figure 2

Master or slave rear radars are not fitted correctly (unclipped or poorly installed)

Diagnostic Trouble Code (DTC) C1114F3 - Lane change assistance control module restricted view, logged with address 003C or 00CF

3) In the event one or both control units are loose/detached - Refer to Figures 2 (Before adjustment) and 3 (After adjustment) and also reference Rep.Gr - 44 Lane change assist control units (J769 and J770) - To remove and fit
