Technical product information

Topic	New Continental GT, GTC, New Flying Spur - Blind spot monitors not functional DTC C1114F3 logged in address 003C or 00CF
Market area	Russische Föderation (5RU),Australia E04 Bentley rest Asia and Australia (6E04),China 796 VW Import Comp. Ltd (Vico), Beijing (6796),Germany E02 Bentley rest Europe (6E02),Japan E03 Bentley Japan (6E03),Korea, (South) E08 Bentley South Korea (6E08),United Arab Emirates E06 Bentley Middle East and Africa (6E06),United Kingdom E01 Bentley UK (6E01),United States E05 Bentley USA and rest America (6E05)
Brand	Bentley
Transaction No.	2062884/2
Level	EH
Status	Approval
Release date

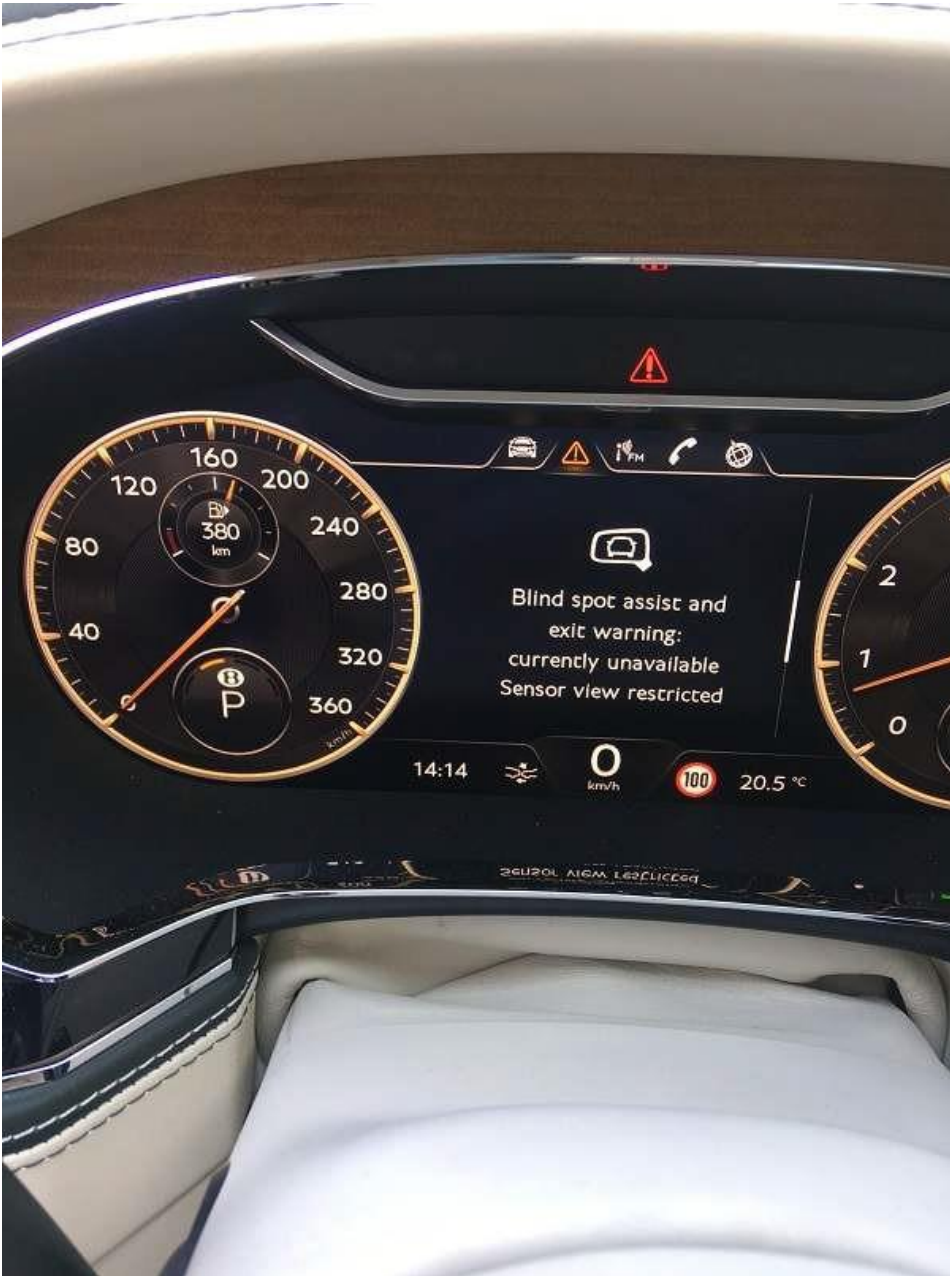
Figure 1

Blind spot monitors (Wing mirror illuminations) are not functional in conjunction with sporadic Bentley assist warnings present in the DIP (Figure 1)

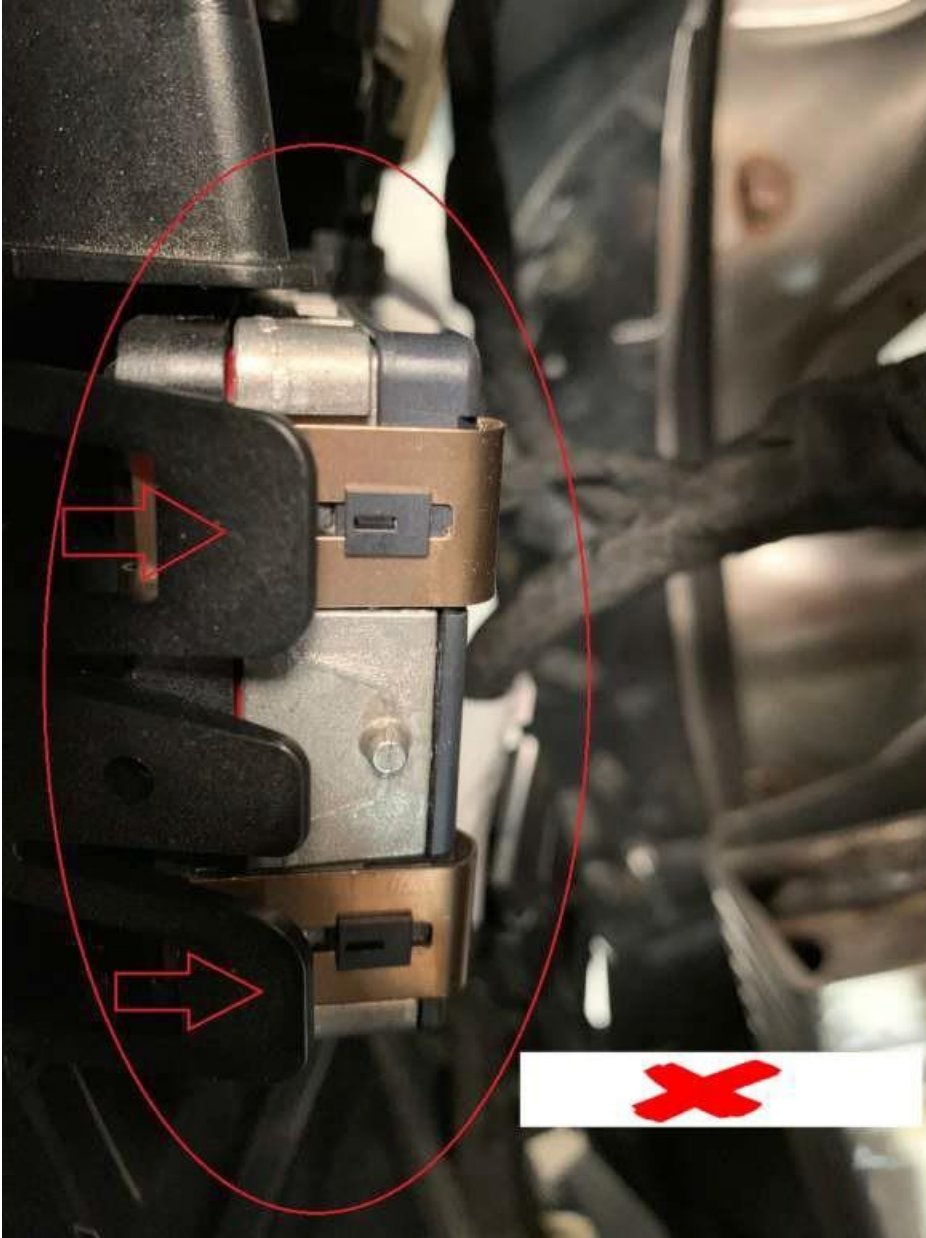
Figure 2

Master or slave rear radars are not fitted correctly (unclipped or poorly installed)

- 1) Refer to the Repair manual for the rear radar fitment location - Ensure the surrounding area of each radar is as follows:
 - Clean from debris/dirt
 - No Aftermarket paint films/vinyl's are applied over the top of the rear radars
 - No Aftermarket body modifications are fitted which could inhibit the operation of the radar signals
- 2) Verify the diagnostic address in which the DTC is evident as follows:
 - 003C: Inspect the RHS rear radar fitment and/or bracket damage
 - 00CF: Inspect the LHS rear radar fitment and/or bracket damage
- 3) In the event one or both control units are loose/detached - Refer to Figures 2 (Before adjustment) and 3 (After adjustment) and also reference Rep.Gr - 44 Lane change assist control units (J769 and J770) - To remove and fit
