| TSIB 21-02 | | 19-Apr-2021 |
| TITLE: | <b>Possible Modine Radiator Fan Harness Routing Pinch Point</b> | |
| APPLICABILITY: | All Xcelsior's built between 01-Jan-2018 and 01-Feb-2021 with a Modine engine coolant radiator. | |

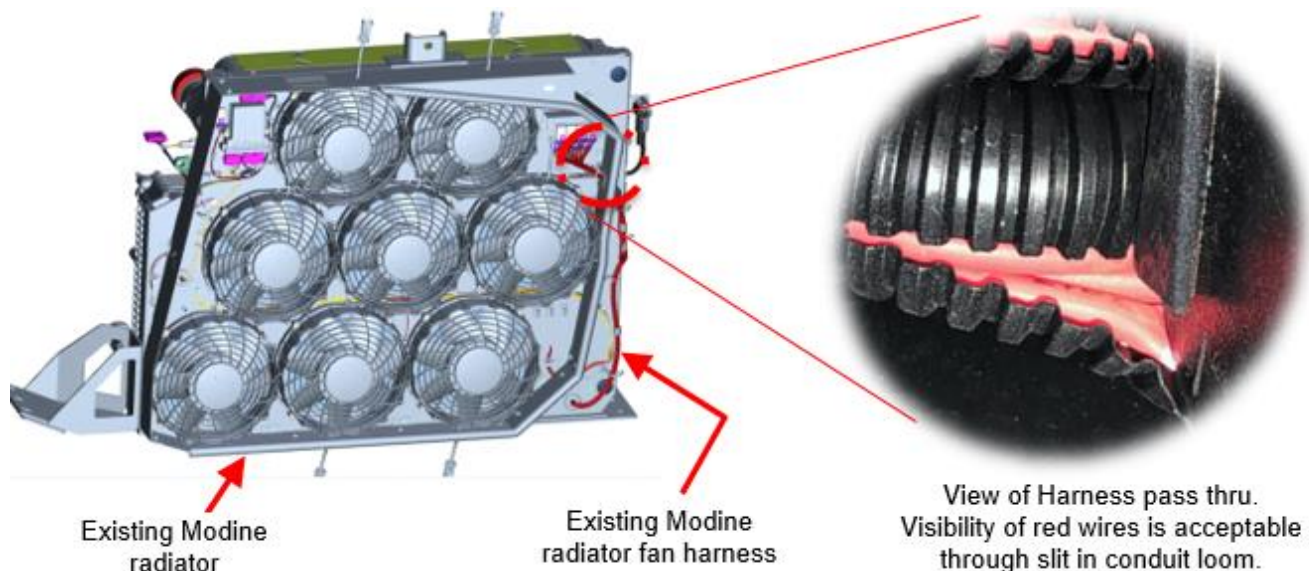
**Figure 1: Radiator Fan Harness Potential Pinch Location**

New Flyer has observed instances where the radiator fan power harness can be pinched potentially causing damage to the wires of the harness. This issue may appear on any New Flyer Xcelsior Buses with an Modine engine coolant radiator built between 01-Jan-2018 and 01-Feb-2021. It is recommended that customers inspect this harness for possible pinching at the next service interval on affected buses. Details on location of the pinch point and criteria can be found below.

1. Open the radiator access door and inspect the radiator fan wiring harness where it passes through the recirculation shield as shown below.

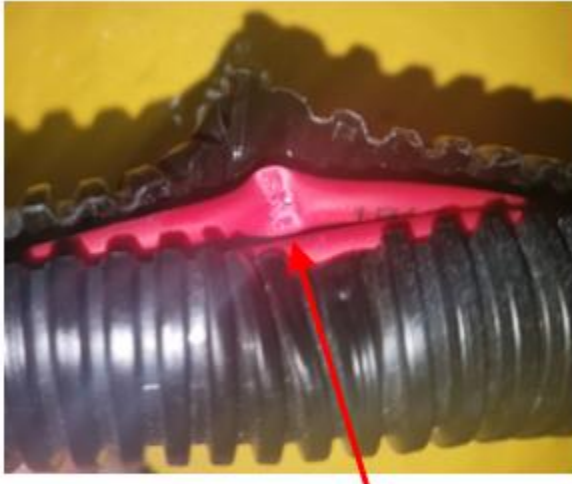
**Figure 2: Radiator Fan Harness Failure Criteria**

Pinched harness showing exposed copper through the insulation, or severely pinched wires must be replaced.

harness fails the criteria the harness will need to be replaced, contact your local Modine distributor to have the harness replaced. If the harness passes the criteria, then reinstall the recirculation shield and put bus back in service.

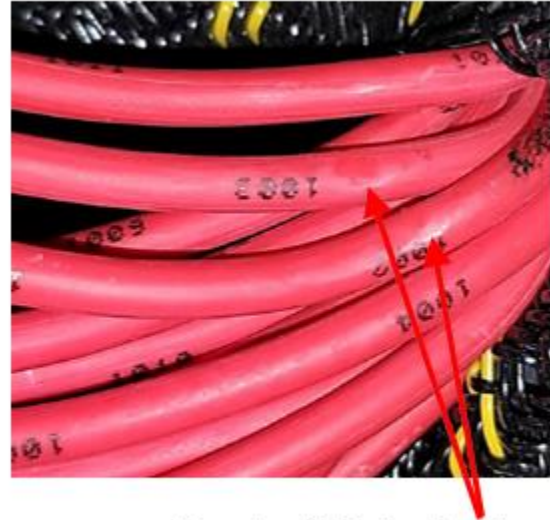
Example of light abrasion shown is acceptable to red wire insulation
