TECHNICAL SERVICE INFORMATION BULLETIN

TSIB 21-03 Rev. A		April 23, 2021
TO:	All Operators	
TITLE:	Revised Air Compressor Scroll Bearing Lubrication Schedule	
APPLICABILITY:	All New Flyer Xcelsior Buses Equipped with Powerex Direct Drive Electric Scroll Type Air Compressors.

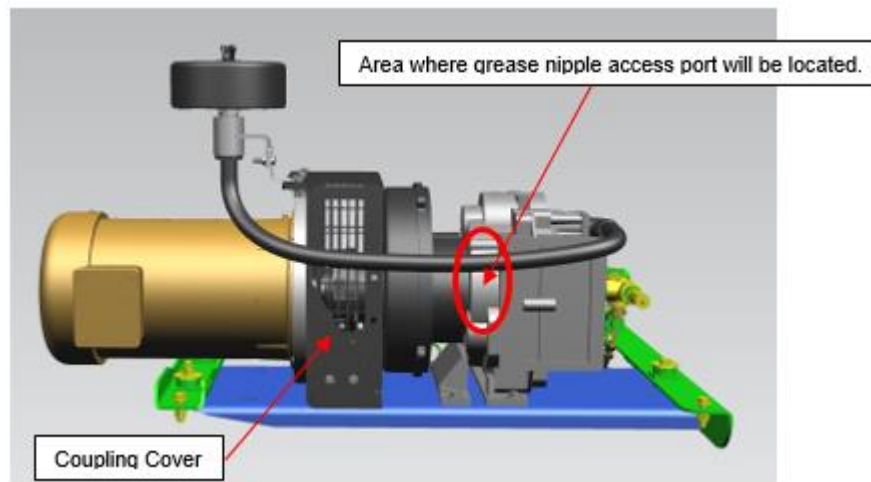
Figure 1: Location of Grease Nipple Access Port. (curb side version shown)

The scroll bearing lubrication nipple is accessed through an access port on the street side of the compressor housing. In some cases there may also be an assess port on the curb side of the compressor. Figure 1. Remove the rubber plug that covers the access port.

Remove the coupling cover (Figure 1) and turn the shaft to align the grease nipple with the access port. Using a Powerex grease gun (Special Tool P/N 6403621) and extension adaptor, engage the grease nipple and apply the correct amount (two strokes of the grease gun handle) of grease NF P/N 6403622. Figure 2.

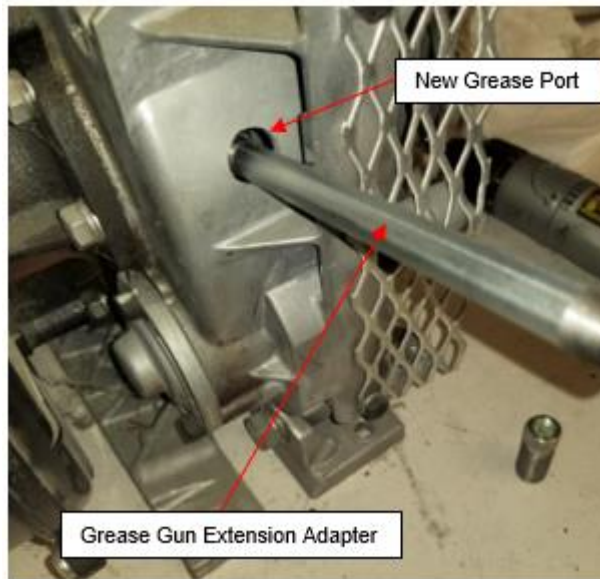
Figure 2: Grease Gun Extension Adapter on Grease Nipple.

NOTE: Pump grease gun before feeding, this eliminates air from the grease passage of the extension adaptor.
