QUARANTINE NOTICE

Reference number:	QN-30-1497	Issued: 21 April, 2021
Subject:	Connector Repair Process for Weak GPS Signal	
Model(s):	DBX	
VIN Range:	Refer to the separately published list of affected Vehicle Identification Numbers (VINs)	
Applicable to:	All Dealers	
Distribute to:	After Sales Manager Executive Manager Service Manager Sales Manager	Warranty Staff Technician(s) Parts Staff

Reason for this Quarantine Notice

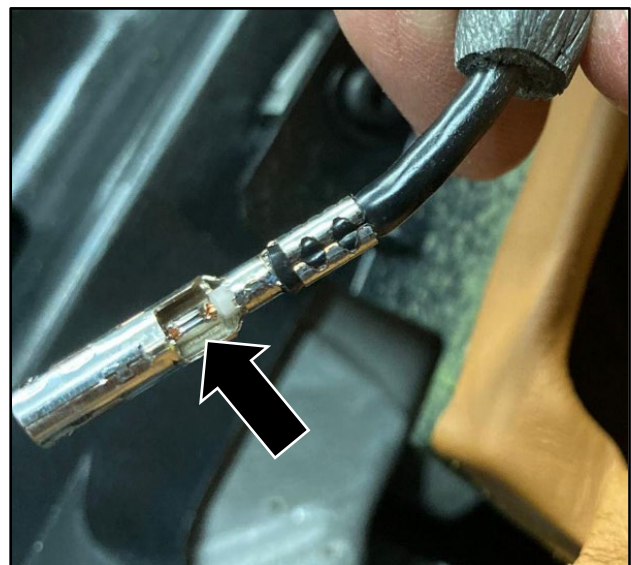
Figure 4

Note: This image shows a connector before any tape is installed.

6. Remove the connector from the applicable connector housing (refer to Figure 4).
