QUARANTINE NOTICE

Reference number:	QN-63-1466	Issued: 12 April, 2021
Subject:	DCDC Convertor Software Update	
Model(s):	DBX	
VIN Range:	Refer to the separately published list of affected Vehicle Identification Numbers (VINs)	
Applicable to:	All Dealers	
Distribute to:	After Sales Manager Executive Manager Service Manager Sales Manager	Warranty Staff Technician(s) Parts Staff

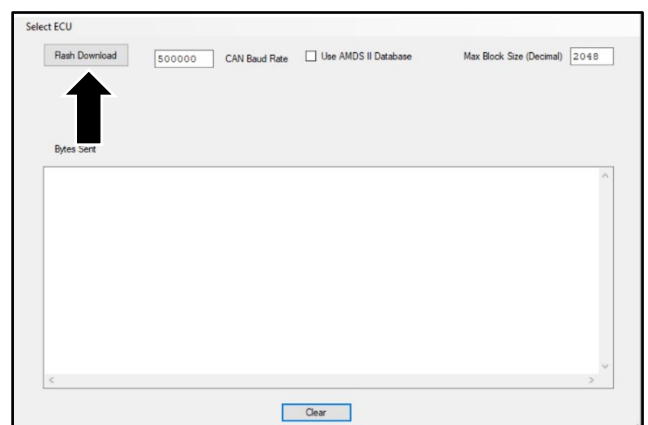
Figure 3

Note: A '48V warning' and 'suspension warning' message will show on the instrument cluster.

6. Select "Flash Download" (refer to Figure 3).

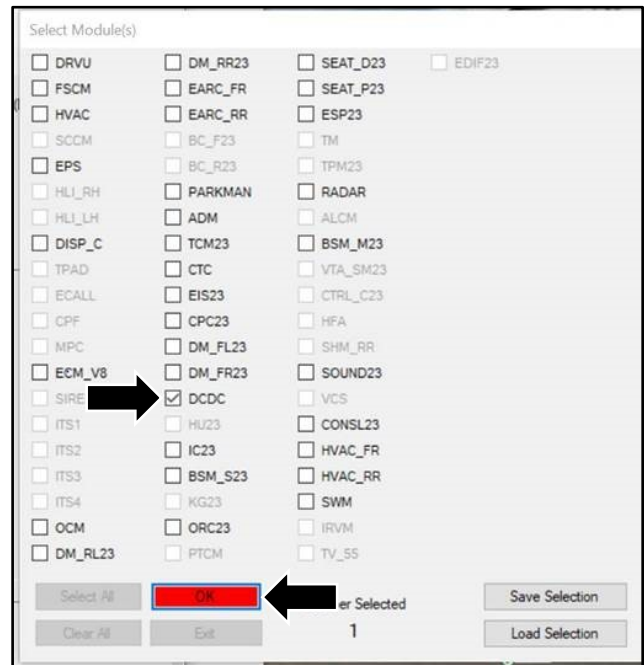
Figure 6

Note: A '48V warning' and 'suspension warning' message will show on the instrument cluster.

- 13. Select "DCDC" then click "OK" (refer to Figure 6).
