SERVICE BULLETIN

Reference number:	SB-07-1473	Issued: 21 April, 2021
Subject:	Active Differential Wiring Loom Inspection	
Model(s):	Vantage 21MY	
Applicable to:	All Dealers	
Distribute to:	After Sales Manager Executive Manager Service Manager Sales Manager	Warranty Staff Technician(s) Parts Staff

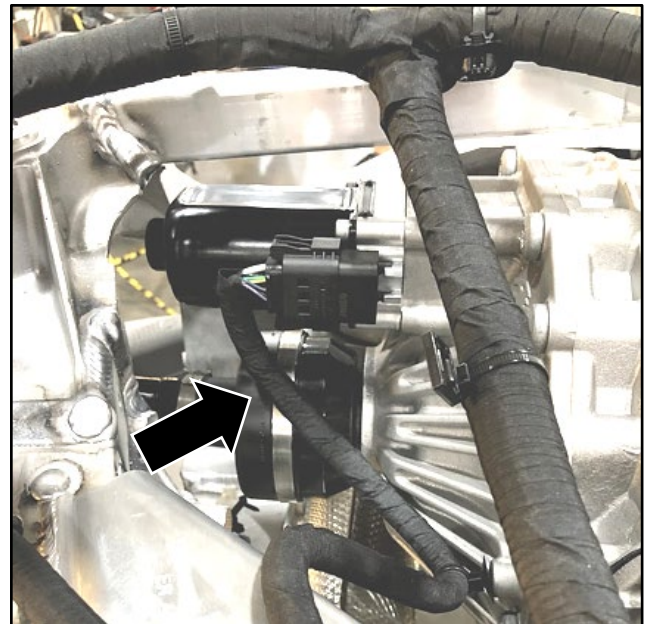
Figure 1

1. Disconnect the battery (refer to Workshop Manual procedure 14.01.CA).
2. Use applicable equipment to lift the vehicle and make it safe.
3. Remove the rear undertray (refer to Workshop Manual procedure 01.02.PB).
4. Do a check for damage to the active-differential wiring loom. Damage can occur where the loom touches the drive shaft (refer to Figure 1).

5. If there is damage to the active-differential wiring loom, you must raise a SpotLight case.

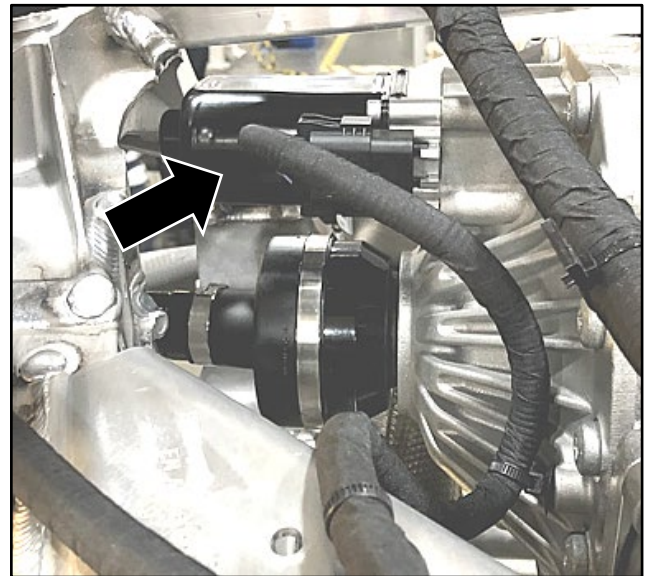
Figure 2

6. Examine the position active-differential wiring loom. The correct position is shown (refer to Figure 2).
If the wiring loom is installed correctly no more steps are necessary.

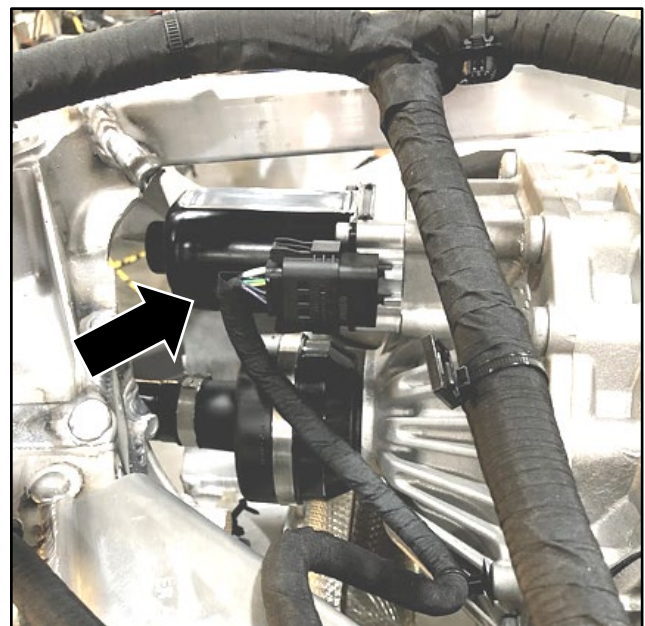
Figure 3

Aston Martin has found that on some Vantage 21MY vehicles with automatic transmission, it is possible for the wiring loom for the active differential to be installed in the incorrect position. This can cause it to rub against the driveshaft.

7. If the active-differential wiring loom is in the position shown (refer to Figure 3), do the actions that follow:
 - Disconnect the wiring loom and rotate it 360 degrees to the correct position (refer to Figure 2).
 - Connect the wiring loom and its fixings.
