## SERVICE BULLETIN

Classification:	Reference:	Date:
AN21-003	NTB21-029	April 6, 2021

### SOFTWARE UPDATE FOR INFOTAINMENT ISSUES

**APPLIED VEHICLES:** 2019-2020 Rogue (T32)

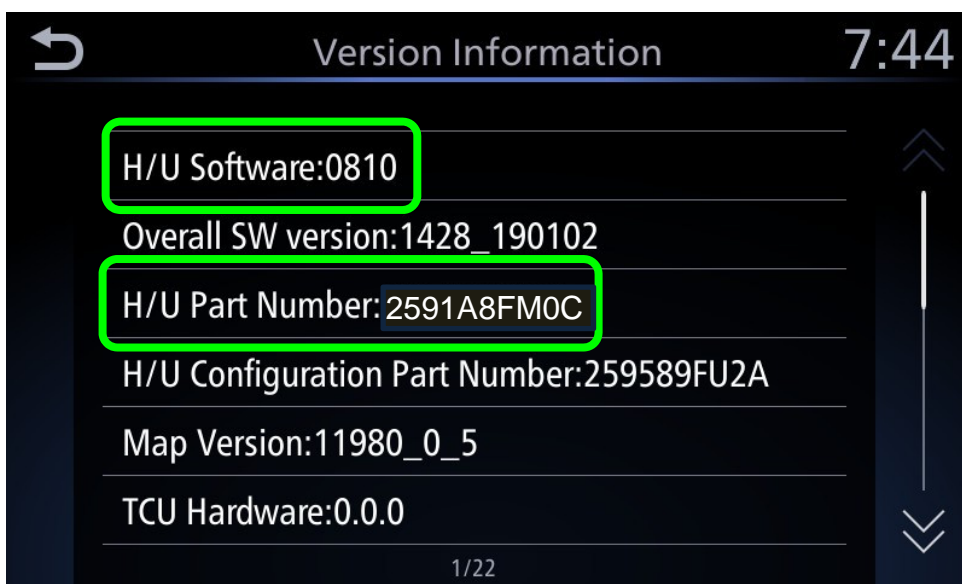
4. Using Figure 5 for reference, confirm the following:
- a. The **H/U Software** version is 810,
  - b. And the **H/U Part Number** is 25915-8FM0C or 2591A-8FM0C.
- If the **H/U Software** version and the **H/U Part Number** match, proceed to step 5 on page 5, to update the AV control unit.
  - If either the **H/U Software** or the **H/U Part number** do not match, this bulletin does not apply. Refer to the ESM for further diagnostic information.

**NOTICE** To avoid damage to the vehicle, do not update the AV control unit if the **H/U Part Number** is not one listed above. Doing so may cause the AV control unit to operate incorrectly.

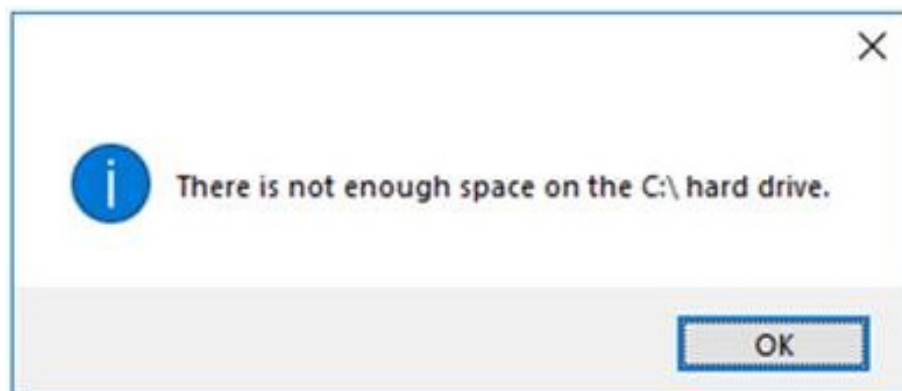
Figure 8

- The update-software is estimated to take **4 hours** to download to the USB drive.
  - If, while attempting to download the software to the ASIST station, you receive the message shown in Figure 8:
    - a. First, attempt to clear space on the ASIST station hard drive.
    - b. If space on the hard drive cannot be cleared, email Bosch at **nissan.dealers@us.bosch.com** for additional options.

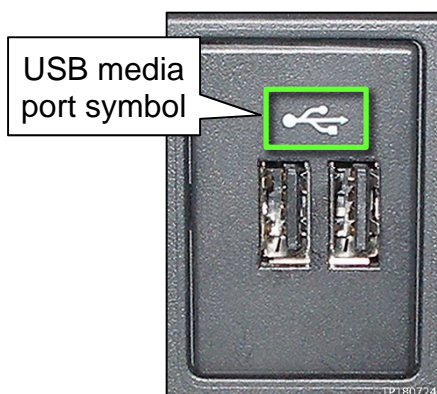
Figure 11

16. Insert the USB drive with infotainment update-software into the vehicle's USB media port (see Figure 11).

**NOTICE** Do not insert the USB drive into a charging port. If used, the update-software and/or USB drive may become damaged. Only insert the USB drive in a USB media port.

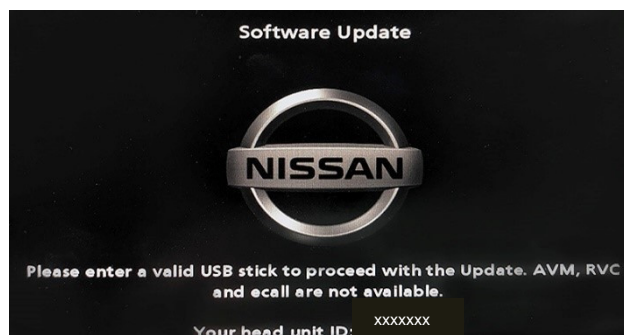
- The screen in Figure 14 may briefly appear. **Do not remove the USB drive.** The audio system will detect the USB drive and continue the update.
