QUALITY ACTION

CAMPAIGN BULLETIN

Rear Coil Spring Inspection Dealer Inventory

Reference: PM977

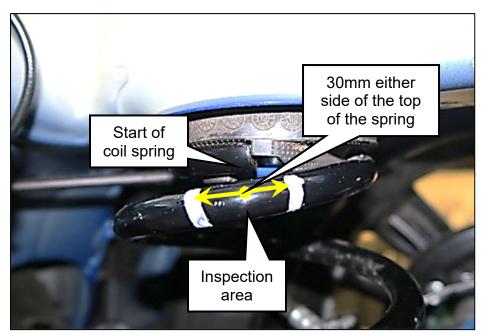
The indentations can be found in any position on the spring in the inspection area

Note: The inspection area in Figure 2 was marked with white paint.
