SERVICE BULLETIN

Classification:	Reference:	Date:
EC21-001A	NTB21-006A	March 2, 2021

MIL ON WITH DTC P0128 STORED

APPLIED VEHICLES: 2021 Versa (N18)
APPLIED TRANSMISSION: 5-speed M/T (RS5F91R)

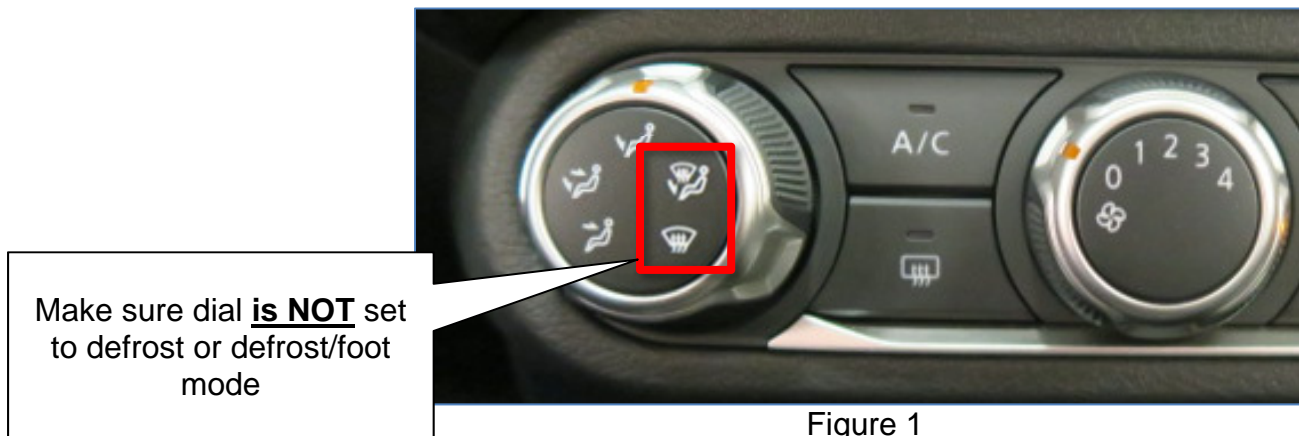
2. Confirm the HVAC air flow control dial **is NOT** set to defrost or defrost/foot mode.

NOTE: If unable to start the reprogram (the Start button is greyed out), refer to Figure 1 on page 2 and confirm the HVAC air flow control dial is NOT set to defrost or defrost/foot mode.
