SERVICE CAMPAIGN BULLETIN

Classification: EC21-002	Reference: NTB21-015	Date: March 2, 2021
-----------------------------	-------------------------	------------------------

VOLUNTARY SERVICE CAMPAIGN 2021 VERSA; ENGINE CONTROL MODULE

CAMPAIGN ID #: PM970
APPLIED VEHICLES: 2021 Versa (N18)
APPLIED TRANSMISSION: 5-speed M/T (RS5F91R)

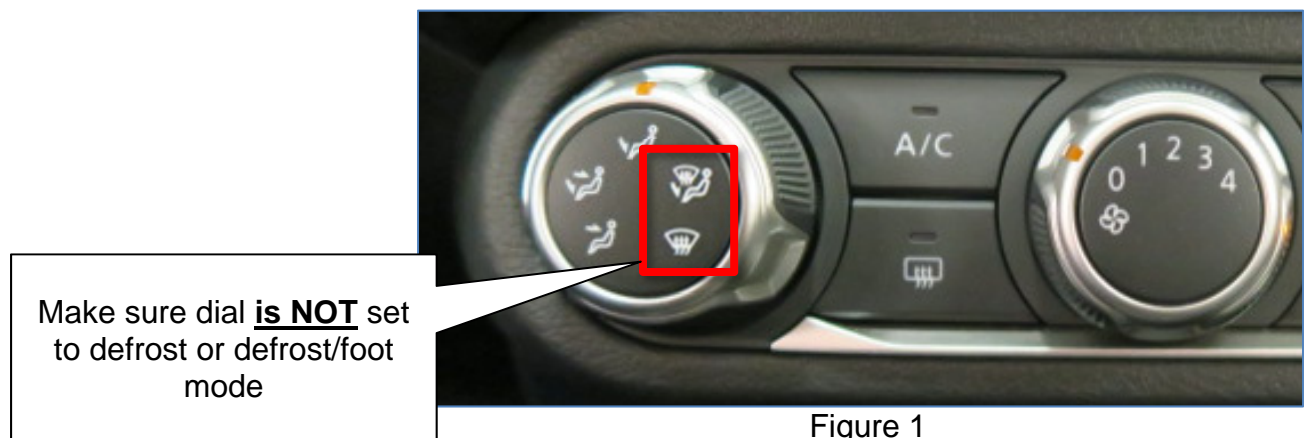
- Confirm the HVAC air flow control dial **is NOT** set to defrost or defrost/foot mode.

NOTE: If unable to start the reprogram (the Start button is greyed out), refer to Figure 1 on page 3 and confirm the HVAC air flow control dial is NOT set to defrost or defrost/foot mode.
