QUALITY ACTION

CAMPAIGN BULLETIN

Inner Socket (Tie Rod) Inspection Dealer Inventory

PM973 – 2020 SENTRA INNER SOCKET (TIE ROD) INSPECTION

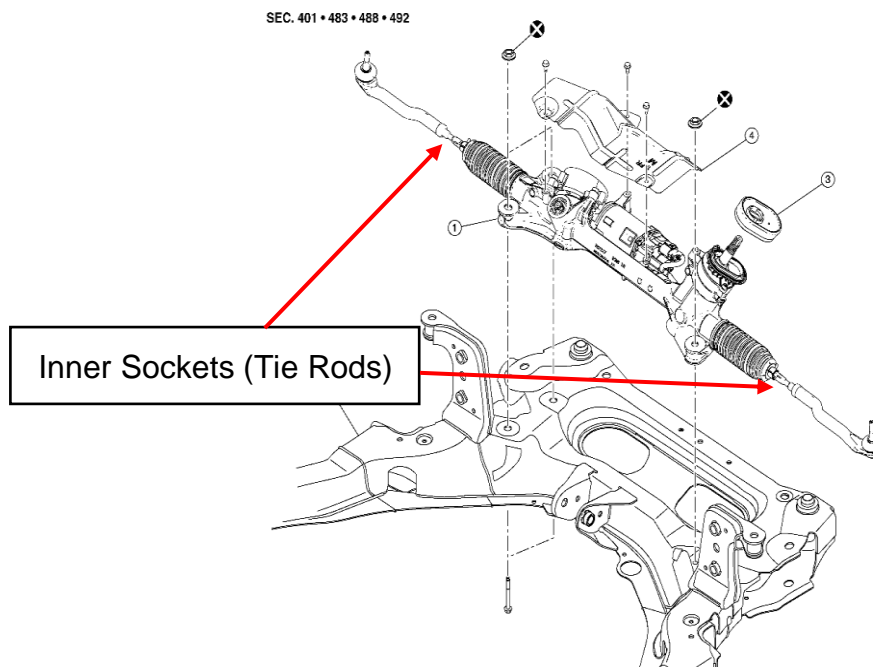
Figure 1

1. Place the vehicle on a suitable lift and fully lift the vehicle.
2. Locate the LH and RH inner sockets (tie rods). (Figure 1)

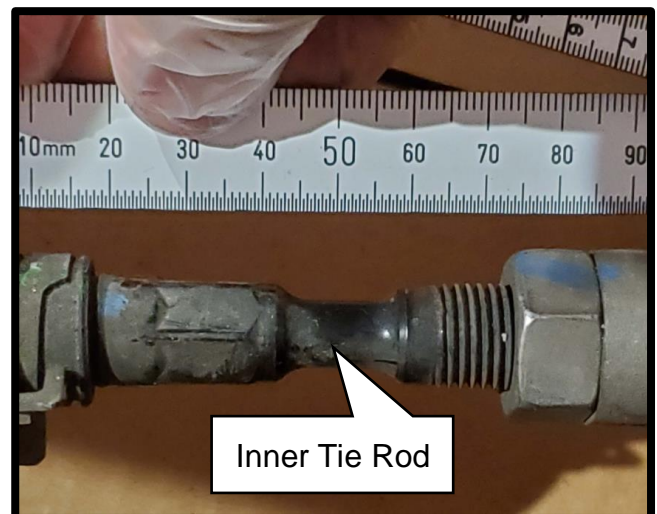
3. Place a straight ruler on both LH and RH inner tie rods as shown in Figure 2 and continue to Step 4 for inspection.

NOTE: The steel rule in Figures 2, 3 and 4 is not intended for measurement purposes but as a straight edge reference.

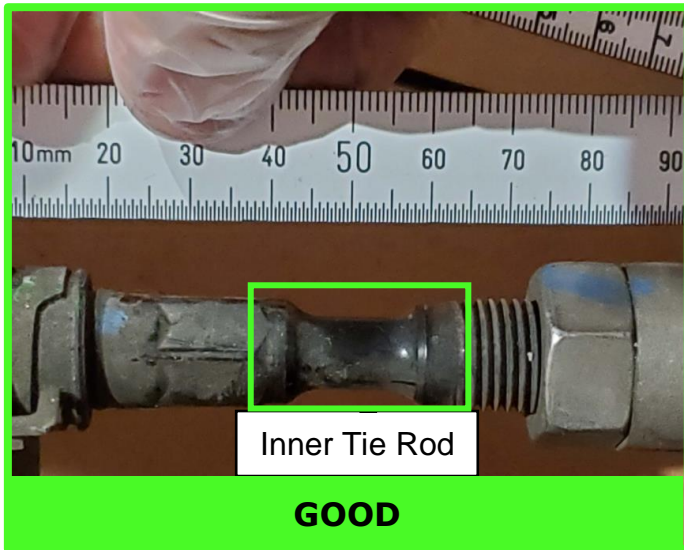
Figure 3

4. Visually inspect both LH and RH inner tie rods for bends. (Figure 3, Figure 4)

- **NO=GOOD:** No further action needed. Lower the vehicle and submit claim using the warranty claims information below "Inspection only No repair".
- **YES=NO GOOD:** Do **NOT** submit a warranty claim, provide clear photos of the affected inner tie rod with a straight edge to FQA using the information below and **HOLD** the vehicle until further notice.
 - a. Take clear pictures of the VIN certification label, the bent inner tie rod, and any damage seen under the vehicle or on the wheel and tire assembly
 - b. Email photos to nafgasupport@nissan-usa.com
 - c. Note LH or RH side.

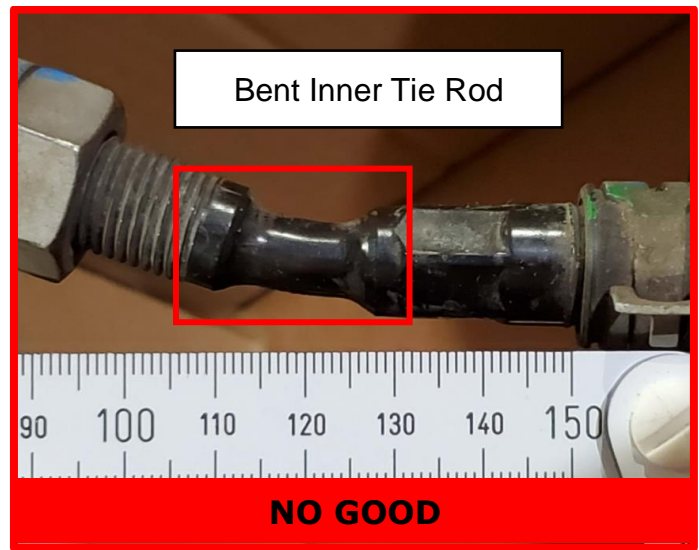
- The straight edge (steel rule) is used to visually confirm the straightness of the tie rods.
- The condition will be easily detectable by visual inspection.
- The picture shown in Figure 4 has an exaggerated bend. Inner tie rods found to be bent, may not be as extreme.
