SERVICE BULLETIN

Classification: AN17-024A	Reference: NTB17-067A	Date: March 11, 2021
------------------------------	--------------------------	-------------------------

2016-2017 MURANO; PHONE WILL NOT CONNECT WITH VEHICLE AND BLUETOOTH® AND PHONE BUTTONS ARE GRAYED OUT IN SETTINGS MENU

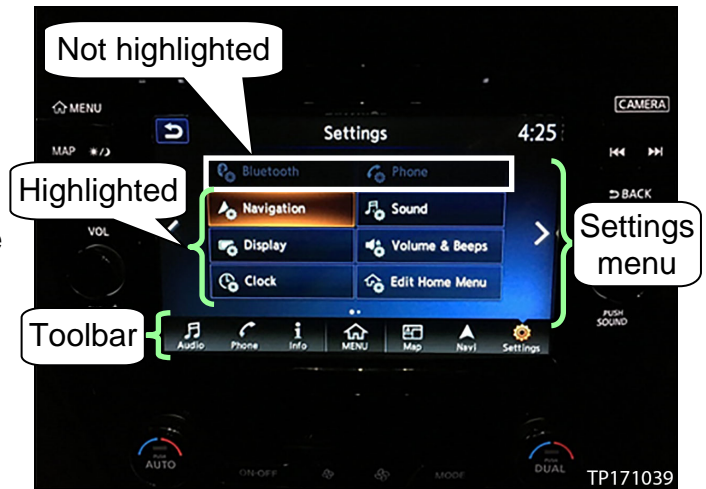
Figure A

- When the incident occurs, the “Bluetooth” and “Phone” buttons in the settings menu of the multi AV display are grayed out (not highlighted) and do not respond when pressed.
- When pressing the “Phone” button in the toolbar or on steering wheel, the message “Please wait..” displays.
- The incident may be intermittent.

Update the Navigation system software using the SD card shown on page 2 and the **SERVICE PROCEDURE** beginning on page 3.
