Service Bulletin

Bulletin No.: 21-NA-064

Subject: Service Heater Soon Message May Turn On with NO DTC Codes Set and NO Adverse Heater Performance Issues

Brand:	Model:	Model Year:		VIN:		Engine:	Transmission:
		from	to	from	to		
Chevrolet	Bolt EV	2017	2017	—	—	—	—

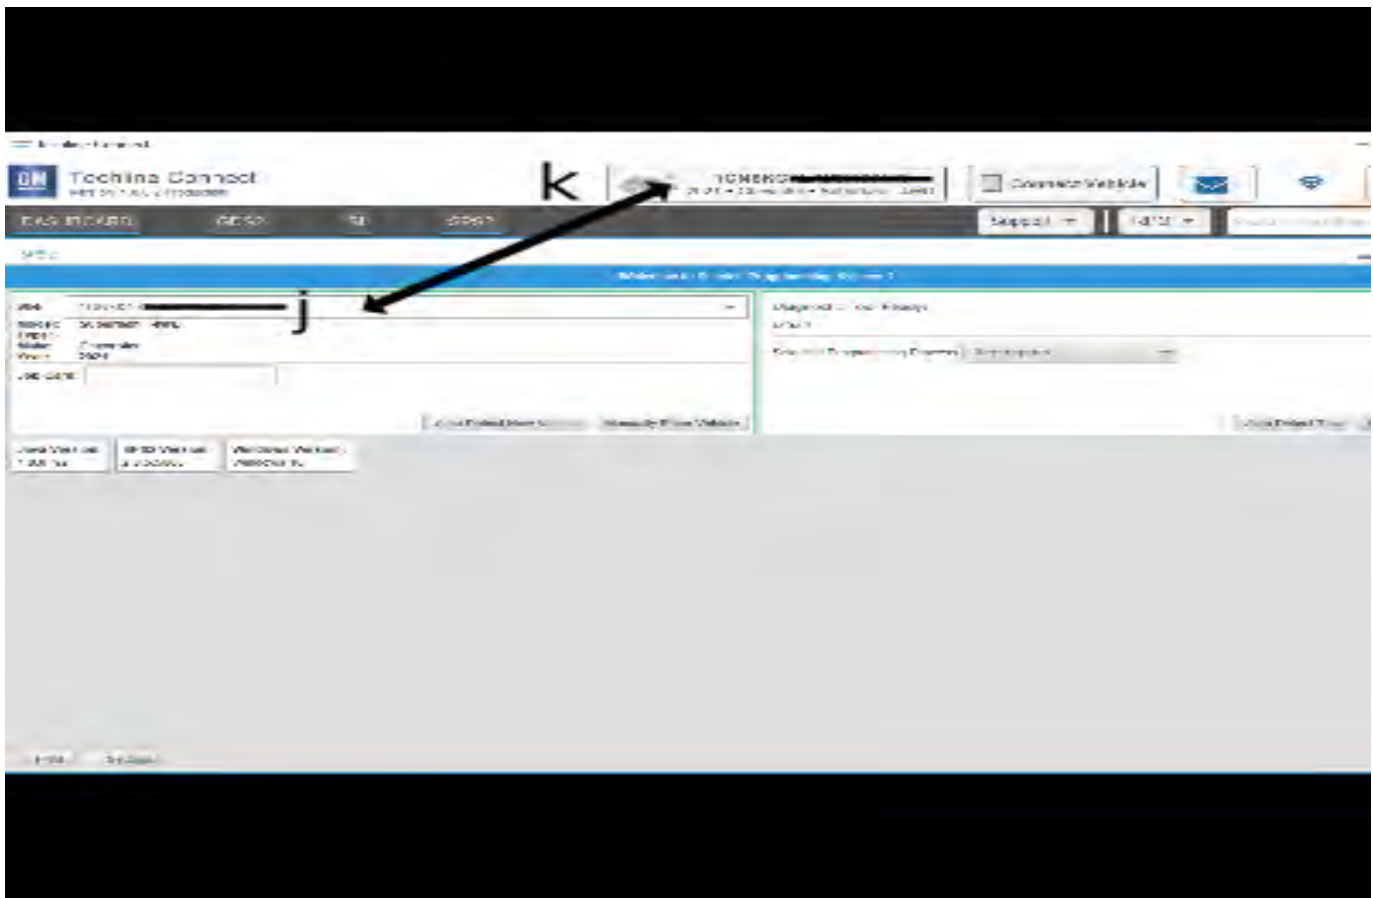
5743643

Caution: Be sure the VIN selected in the drop down menu (1) is the same as the vehicle connected (2) before beginning programming.
