MODEL  
2022MY  
Carnival (KA4)  
w/Ventilated Seats

NUMBER  
241

SUBJECT: **SERVICE ACTION: PASSENGER SEAT VENTILATION  
CONTROL WIRE HARNESS INSPECTION & ADJUSTMENT (SA477)**

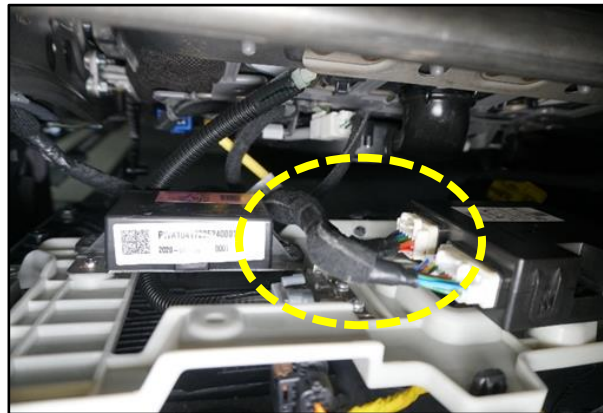
Ventilation Control Wire Harness under Front Passenger Seat

This bulletin provides the procedure to inspect and if necessary, re-route/adjust the location of the ventilation control wire harness of the front passenger seat on some 2022MY Carnival (KA4) vehicles equipped with ventilated seats (SX, SX-P) produced from January 4, 2021 through April 5, 2021, as there is a possibility of damage to the wire harness if it gets caught between the frame bracket and walk-in control unit when the seat is lowered and/or slides forward/rearward. To correct this concern, follow the procedure outlined in this bulletin to inspect and if necessary, relocate the wire harness. Before conducting the procedure, verify that the vehicle is included in the list of affected VINs.

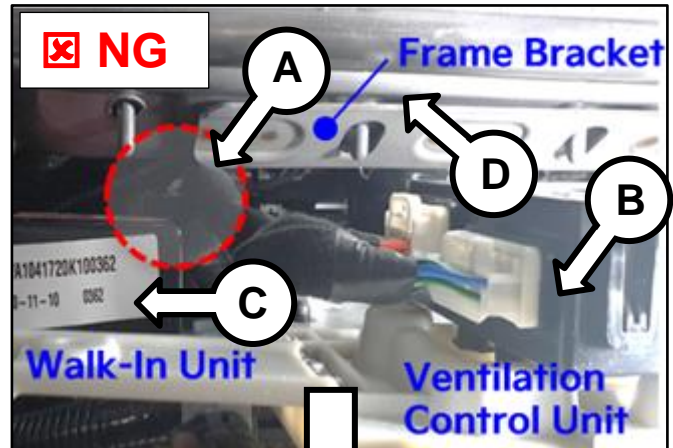
1. Inspect the location/routing of the wire harness (A) from the ventilation control unit (B).
  - If the ventilation control unit wire harness is above (NG) the walk-in control unit (C), the wiring may become jammed between the seat frame bracket (D) when the seat is moved, and re-routing/adjustment is required. Proceed to page 3.

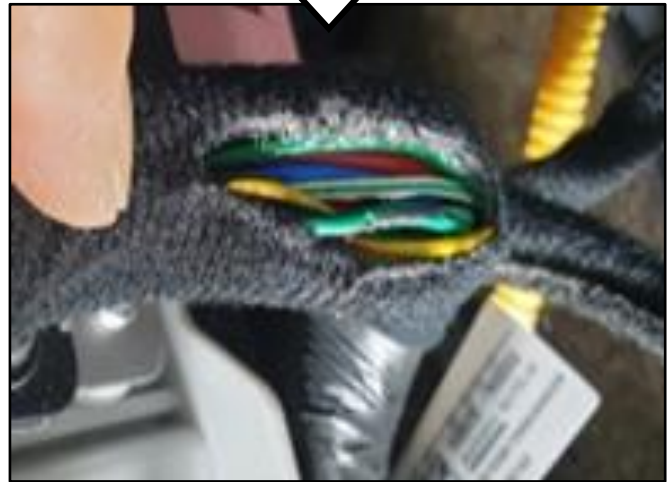
**Note:** Sample image of a damaged wire harness shown to the right.

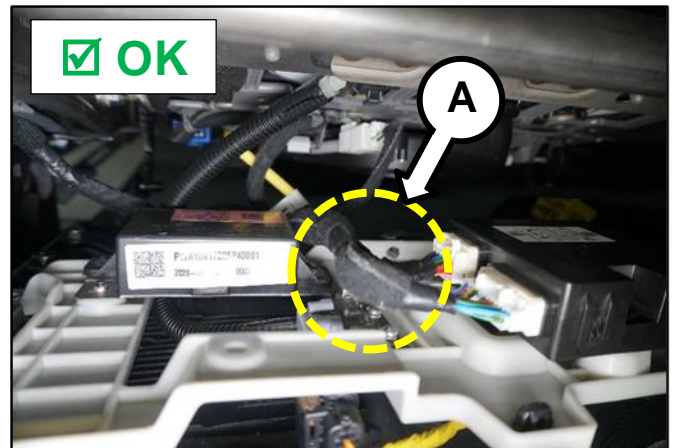
- If the wire harness is located beside the walk-in control unit (OK), as shown, no adjustment is needed.
