# FIELD SERVICE CAMPAIGN

Subject: **Field Service Campaign 14M2**  
**S60 Export Injector Harness Replacement**

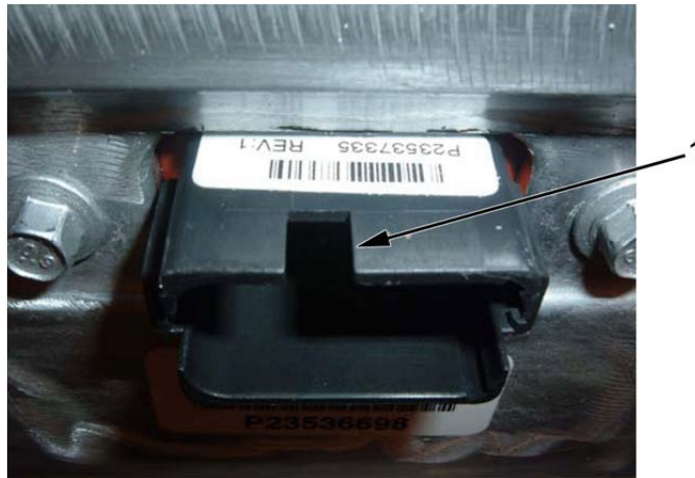
Figure 1 – 12-Pin Electrical Connectors

7. Install the two 12-pin electrical connectors through the camshaft housing. Ensure the fuel injector wiring harness connector is installed into the camshaft housing with the notch facing upwards. If the connector is installed incorrectly, the mating connector cannot be installed. See Figure 1.

8. Install the two bolts securing each 12-pin connector to the camshaft housing. Torque the bolts to 9-12 ft-lbs (12-16 Nm).
9. On the outside of the camshaft housing, install the engine sensor harness 12-pin connectors to the front and rear fuel injector wiring harness connectors.
10. Install the rocker cover cap. **Reference** section “Installation of the Two-Piece Rocker Cover Cap - Diesel Engines Only” in the *EPA07 Series 60 Workshop Manual* (DDC-SVC-MAN-0005).
11. Reconnect battery power, start the engine, and verify repairs.
