Emissions Service Action

Code: 24FX

Subject	Engine Control Module (ECM) Software																									
Release Date	May 06, 2021																									
REVISION SUMMARY	Updated work instructions in the event a start/stop error appears in the instrument cluster																									
Affected Vehicles

Subject: Emissions Service Action 24FX – Engine Control Module (ECM) Software

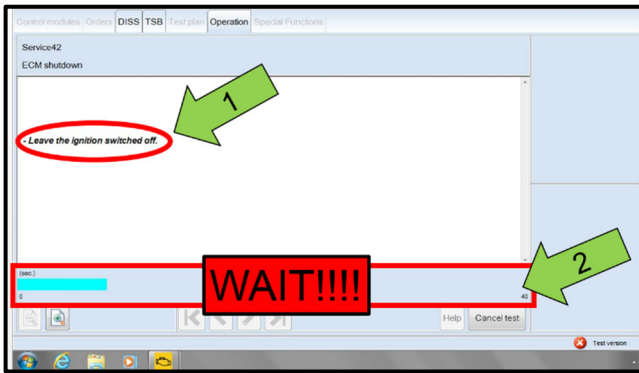
- It is **IMPERATIVE** that **ALL** of the ignition cycle on/off delay requests are fulfilled in their entirety during this flash process <arrow 1>.
- Failing to wait for the ignition on/off timing cycle to complete (progress bar and countdown timer <arrow 2>) before cycling the ignition on/off **MAY** damage a control module.
- Damage to control modules as a result of failing to wait the specified time displayed by the progress bar and countdown timer <arrow 2> are **NOT** covered under this action.

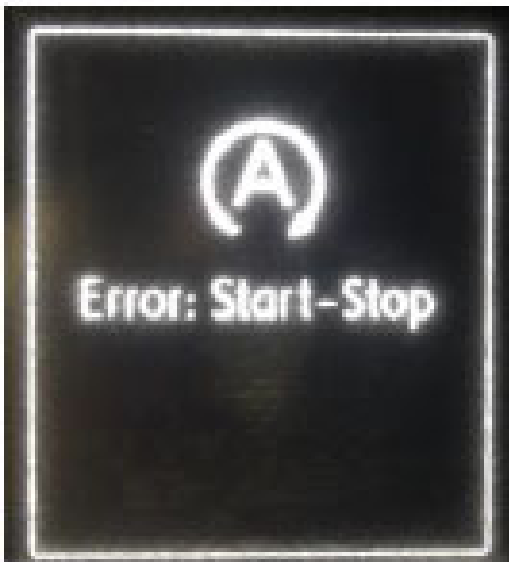
- If the message shown is displayed on the instrument cluster after the flash and it was not present prior to the flash, the ECM adaptation channel for the start/stop activation may have to be changed from inactive to active.
- To change the adaptation channel, use Diagnosis Mode OBD and change the ECM adaptation channel, "*Activation of start/stop function [\$0927]*" from "not active" to "active".
- The adaptation will also change on its own after the vehicle is driven for 50 km (~32 miles). However, the message in the cluster might not disappear until the ignition is cycled after the vehicle has been driven for 50 km (~32 miles).
