## Technical Service Bulletin

**Subject:** Aerials Solenoid Coil

**Applies To:** Certain 2019, 2020 and 2021 Rosenbauer Aerials with Commander chassis installed with a vendor part number of 6030-0000-00.

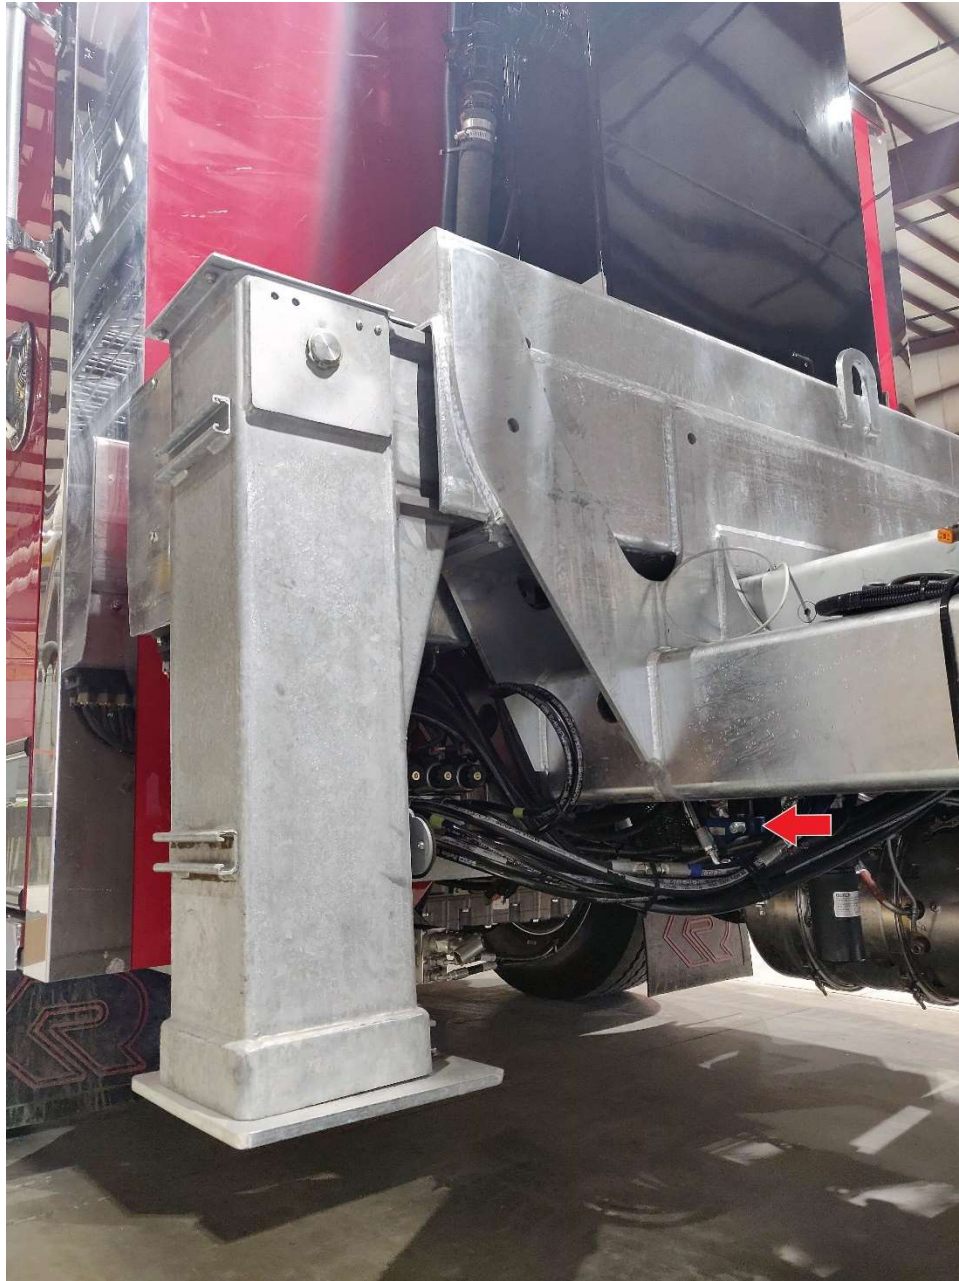
1) Locate blue anodized hydraulic manifold near the aerial PTO hydraulic pump (general location shown in picture below).

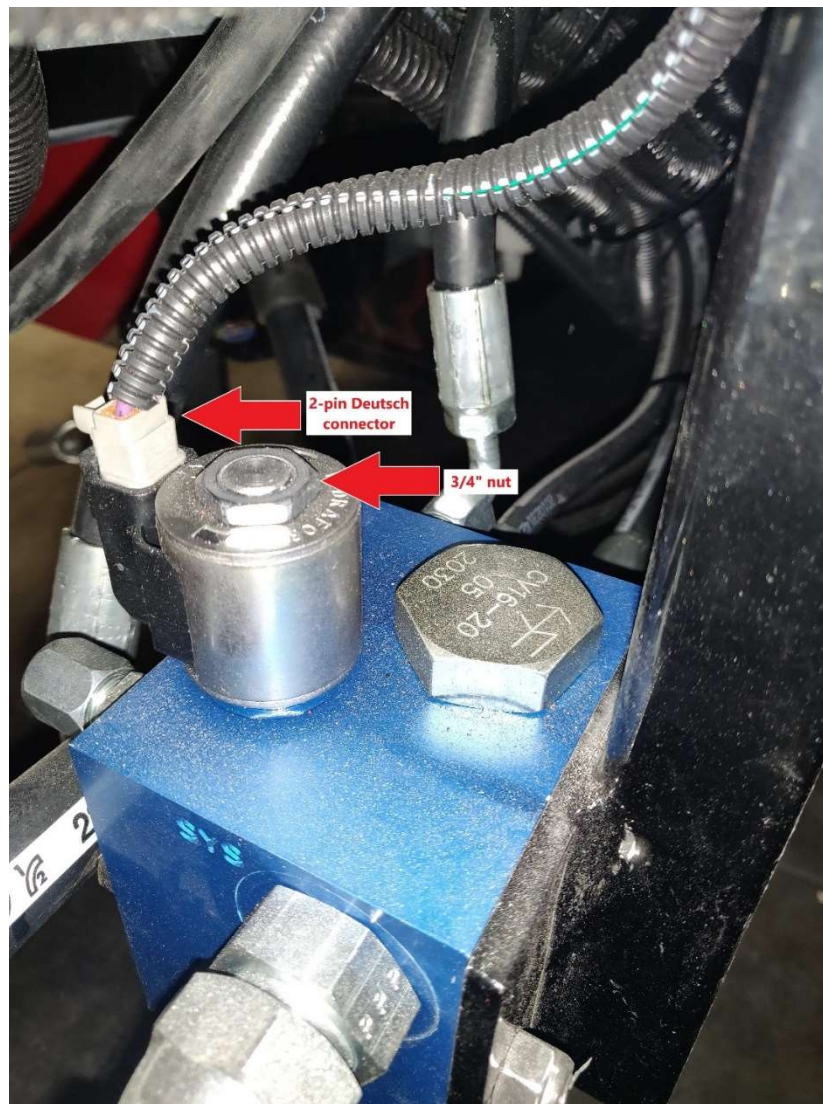
2) Unplug 2-pin Deutsch connector and remove 3/4" nut on top of coil (see picture below).

- 3) Replace old coil with new coil.
- 4) Reinstall nut and reconnect 2-pin connector.
- 5) Test operation before and after installation for high idle function. Contact Rosenbauer Warranty and Customer Service if problems.
- 6) Once complete, install decal in officer kick plate with TSB-042121 and today's date written on it.

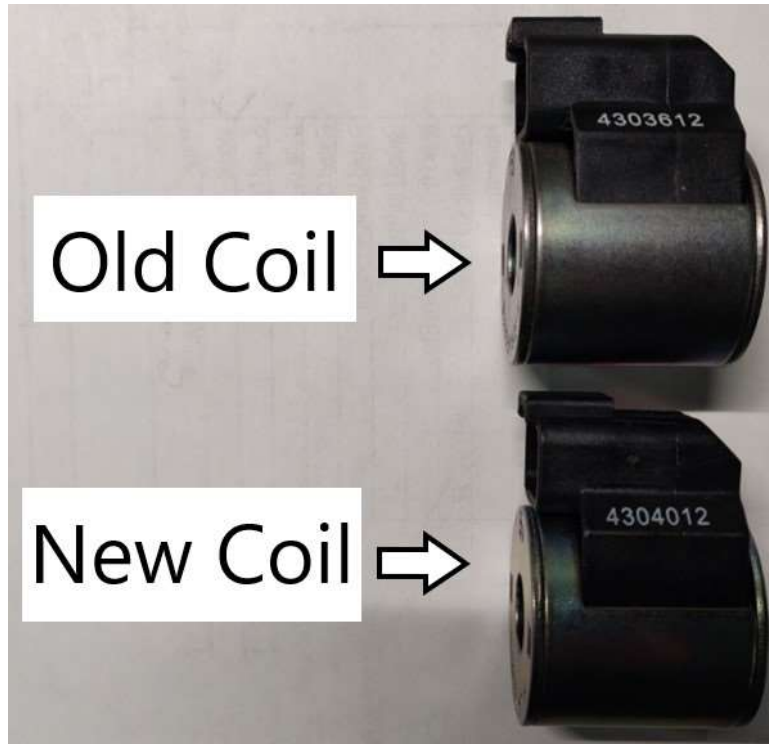
Old coil (unsuppressed) marked with part number 4303612.

New coil (suppressed) marked with part number 4304012.
