Technical Service Bulletin

17 MIL on or noises from the crankcase breather, DTC P052E00 is stored in the ECM

17 21 16 2060033/3 May 6, 2021. Supersedes Technical Service Bulletin Group 17 number 20-10 dated August 26, 2020 for reasons listed below.

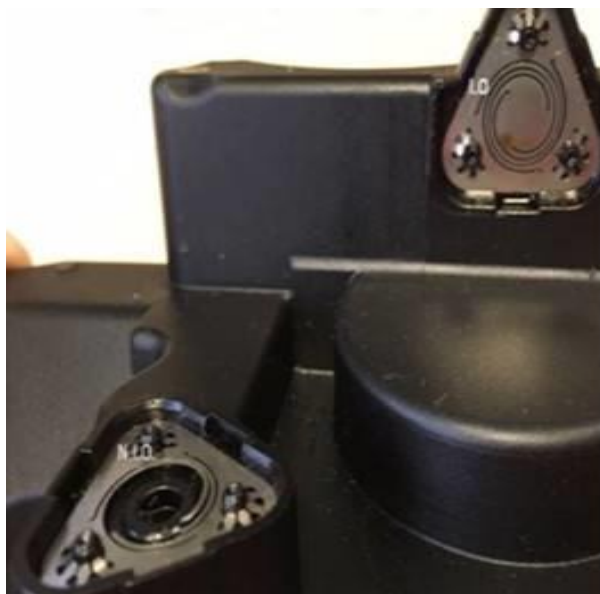
Figure 1. Metal plates.

1. Using the hand vacuum pump VAS 6213 check the membrane of the crankcase breather for leaks; a leak can mean a faulty membrane or elbow piece (see TSB 2060259: *17 MIL on or noises from the engine compartment, DTC P052E00 is stored in the ECM for the elbow piece repair*).
2. Remove the compressor/intake manifold and check the membrane for leaks directly on the crankcase breather. Remove the crankcase breather and check the two metal plates for damage (Figure 1).
If a plate is defective, please use the repair kit 06E 103 772H.

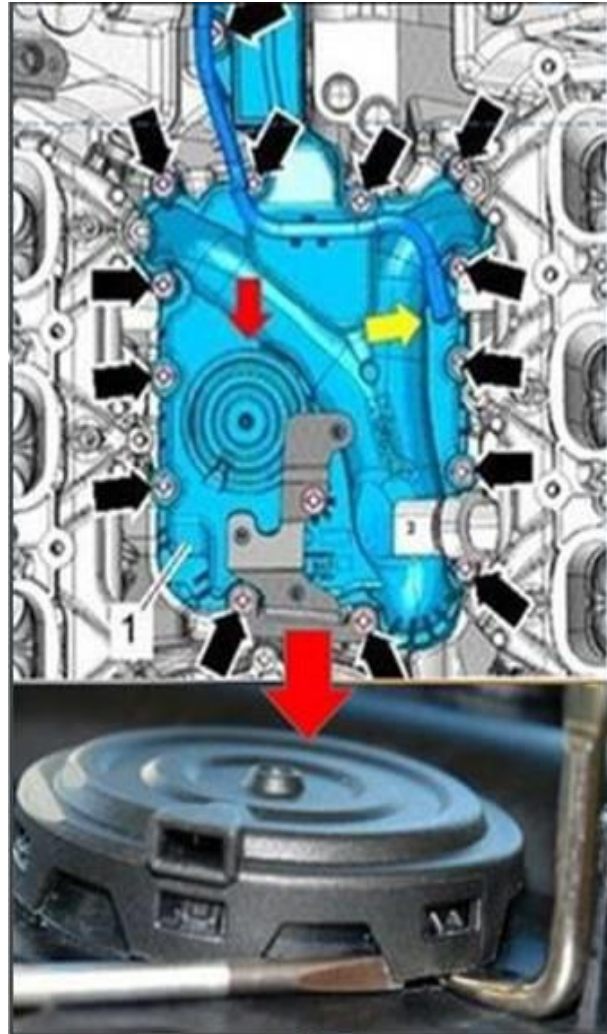
Figure 2. Membrane example.

Fuel additives can cause the membrane to crack.

3. Replace the membrane of the pressure regulating valve (Figures 2-3) (Included in the repair kit 06E 103 772H).
