Technical Service Bulletin

19 Red coolant warning lamp on, DTCs P218100, P017B00, P017C00, and/or P017E00 are stored in the ECM

19 21 16 2062951/1 May 3, 2021.

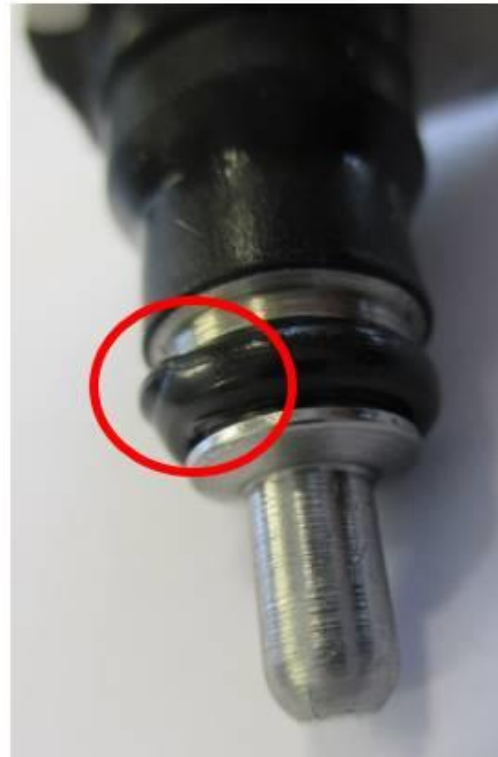
Damage to the O-ring of the temperature sensor can cause water intrusion inside the plastic housing of the coolant temperature sender G407 (cylinder head temperature sensor). The moisture can damage the sensor element. The loss of function can be sporadic.

1. Work through Guided Fault Finding.
2. It is very important to also check whether the O-ring located directly on the tip of the coolant temperature sender G407 is visibly damaged and/or pinched (Figure 1).

Figure 1. O-ring is pinched.

3. Replace the G407 if it is damaged and/or pinched.
