Technical Service Bulletin

19 Coolant level warning light on with coolant marks on the coolant pump - 4.0 TFSI

19 21 17 2048936/3 May 6, 2021. Supersedes Technical Service Bulletin Group 19 number 20-01 dated February 13, 2020 for reasons listed below.

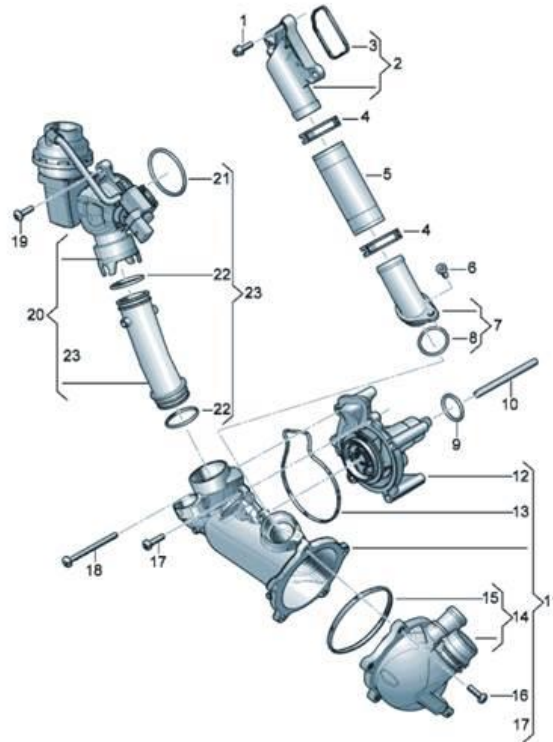
Figure 1. View position complete water pump assembly (rear view).

- There are coolant marks in the area of the coolant pump housing (Figure 1, position 12), the coolant connector union (Figure 1, position 7) or the thermostat housing (Figure 1, position 14).
- After cleaning the coolant marks off and performing another leakage test, check for **fresh** coolant marks on the coolant pump drive (Figures 2 - 6).

1. Fully complete the attached worksheet and attach it to the repair order.
2. Remove the coolant marks and bleed the cooling system according to the repair manual. Then check the cooling system for leaks according to the repair manual:
 - If there is no new leak visible on the coolant pump, **do not** perform any further repairs.
3. If a new coolant leak is detected and can be assigned to a component, take a photo of the **renewed** leak and attach it to the repair order.
4. If there is a coolant leak in the area of the coolant connector union a replacement of the O- ring only (Figure 1, position 8) is sufficient.

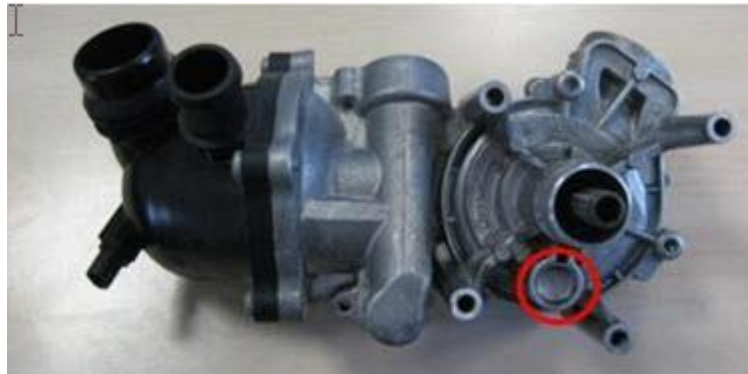
Figure 2. Coolant marks in the plug of the coolant pump housing.

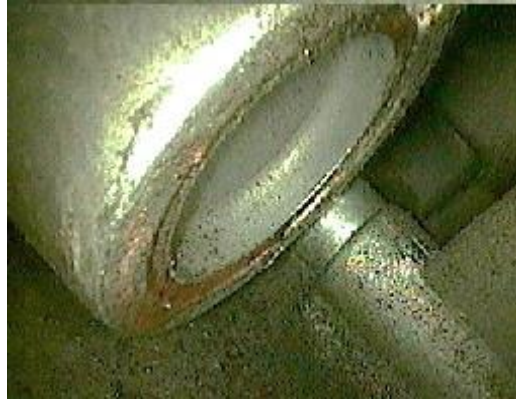
Figure 3. Coolant marks on the flange of the coolant pump housing.

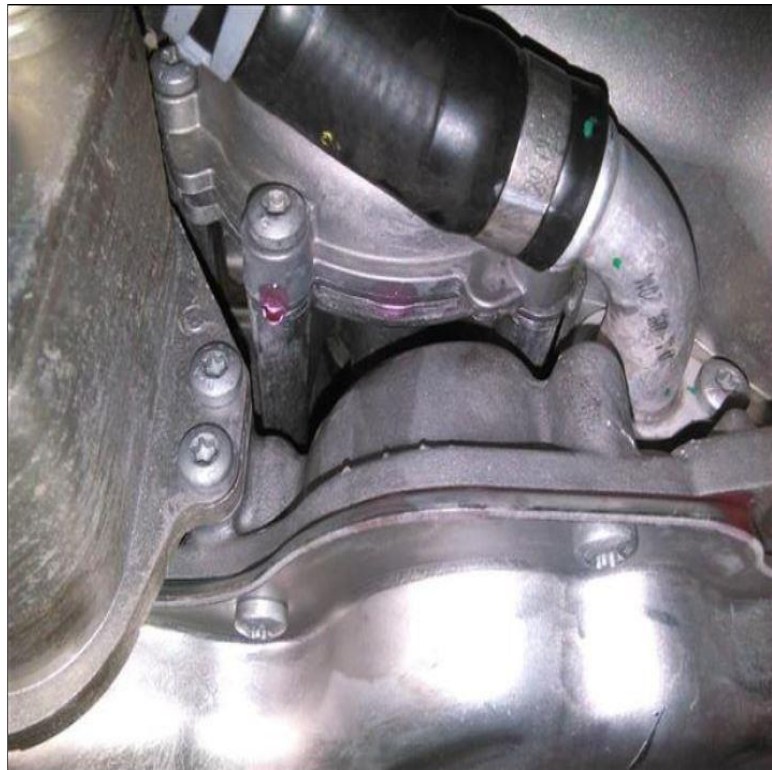
Figure 4. Coolant marks on the flange of the thermostat housing.

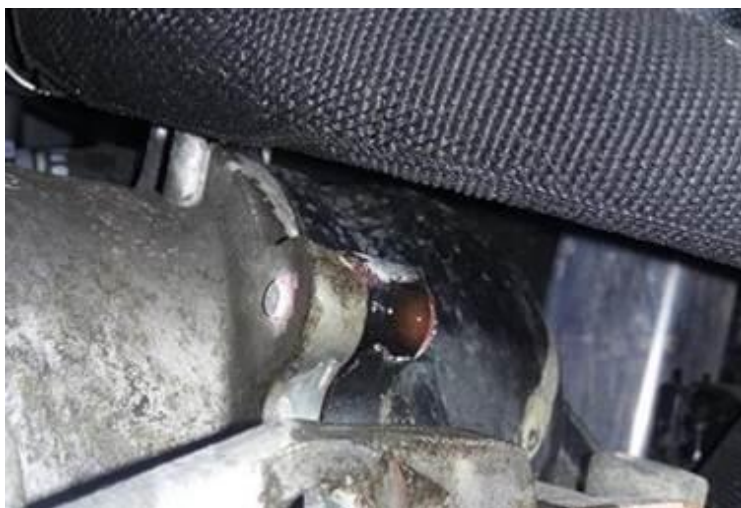
Figure 5. Coolant marks on coolant connector union.

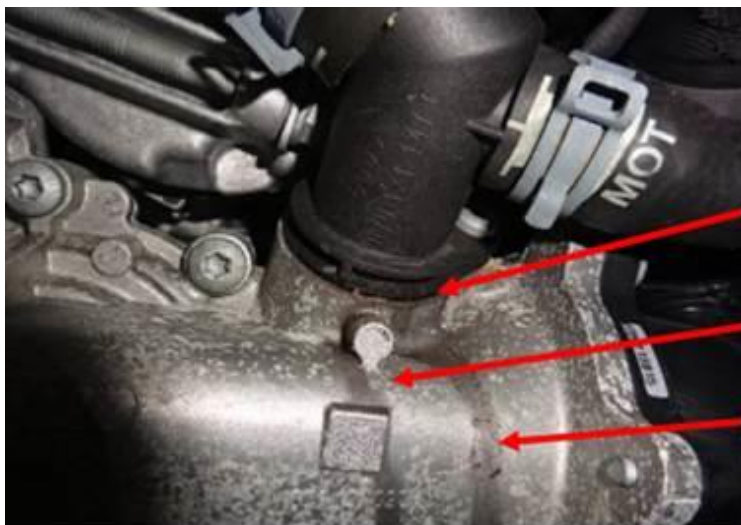
Figure 6. Areas where coolant marks can be found.

The coolant pump housing is sealed off with a slip ring seal to the input shaft. To prevent the seal from drying up, a minor coolant leak is necessary to lubricate the seal.
