| | GROUP<br>ELE | MODEL<br>2021MY<br>Rio (SC) |
| | NUMBER<br>240 | DATE<br>May 2021 |

## TECHNICAL SERVICE BULLETIN

**SUBJECT: SERVICE ACTION: FRONT CAMERA LOGIC IMPROVEMENT FOR DTC 160649 (SA475)**

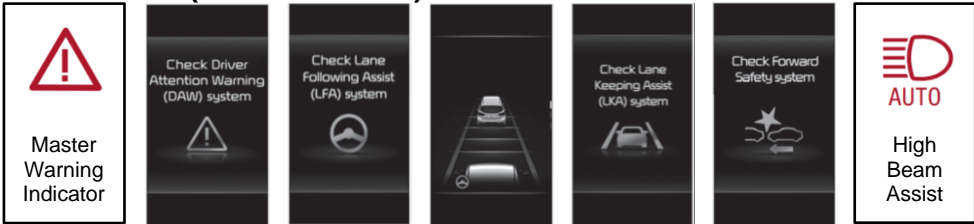
This bulletin provides the procedure to update the software logic of the Front Camera system on some 2021MY Rio (SC) vehicles produced from December 22, 2020 through March 29, 2021 to correct an out-of range fault signal that will disable the supplemental Forward Collision Avoidance (FCA), if equipped, Lane Departure Warning (LDW), Lane Following Assist (LFA), Lane Keep Assist (LKA), Driver Attention Warning (DAW) and High Beam Assist (HBA) systems. If this occurs, several warning messages/lights may display/turn ON and a chime sound are generated to ensure the customer is aware of the malfunction related to DTC C160649. This out-of-range fault signal does not affect the vehicle's steering or braking functions. To correct this concern, apply the improved logic to the Front Camera (FR CMR) system using the KDS ECU Upgrade function as described in this bulletin. For confirmation that the latest reflash has been applied to a vehicle you are working on, verify the ROM ID using the table on page 2 of this bulletin. Before conducting the procedure, verify that the vehicle is included in the list of affected VINs.

**DTC Description:  
C160649 Internal Failure (software error)**

To correct this condition, the ECU should be reprogrammed using the KDS download, as described in this bulletin.
