# Service Bulletin

20-058

May 03, 2021 Version 5

# 2019-21 Passport/Pilot: Popping or Crackling from the Speakers; No Sound from the Audio System; *Network Loss* Message and/or Display Issues

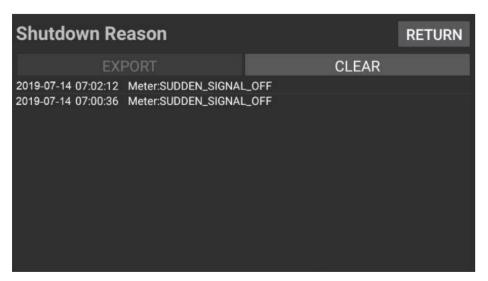
In this example, the cause of the failure can be identified as Meter:SUDDEN\_SIGNAL\_OFF.

Write down any failures; they will be collected on the warranty claim. Then, clear the data.
