234 (Rev 1, 05/13/2021)	April 2021
NUMBER	DATE
	EV (DE EV)
ELE	2019MY~ Niro
GROUP	MODEL

TECHNICAL SERVICE BULLETIN

DRIVE UNIT INSPECTION & REPLACEMENT FOR EV MOTOR RUMBLE NOISE

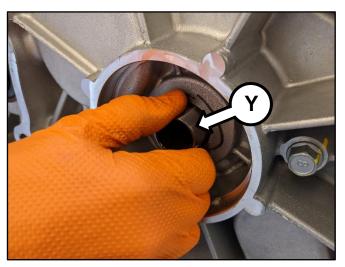
- 3. Rotate the reduction gear input shaft (Y) by hand to check for noise and/or jamming.
 - Normal: Shaft can be turned freely by hand, and no abnormal noise or significant vibration is felt when rotating in any/one direction.
 - Abnormal: Noise or jamming when rotating in any/one direction.

- If an abnormal noise and/or jamming occurs, replace the reduction gear.
- If no abnormal noise is heard, proceed to 'Reduction Gear Vertical Reassembly'.
