Technical Service Bulletin

90 Instrument cluster map is blank after start-up

90 21 02 2063065/1 May 4, 2021.

Model(s)	Year	VIN Range	Vehicle-Specific Equipment
A3	2017 - 2019	All	Navigation

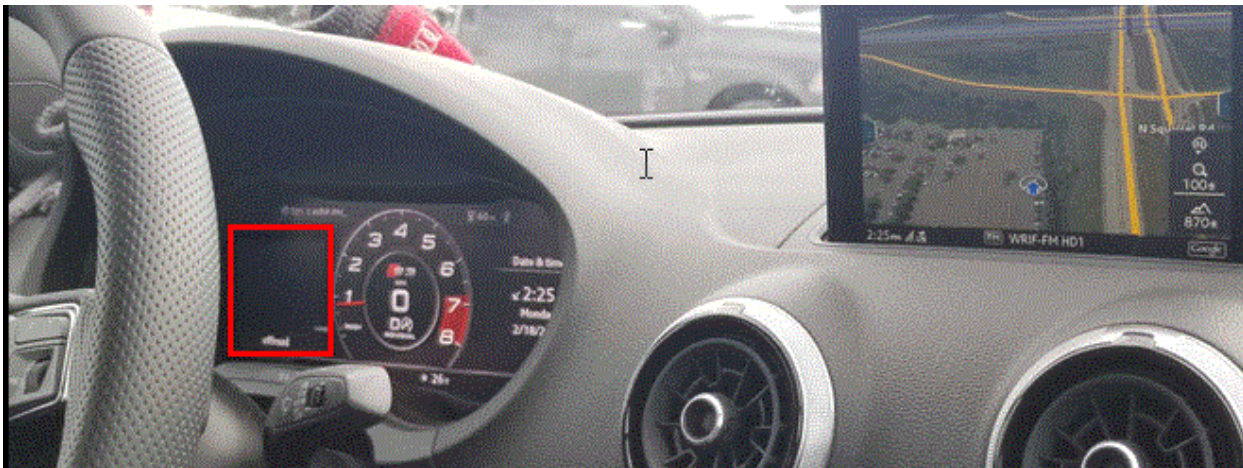
A software bug in the instrument cluster can cause the map not to display if the vehicle is placed in reverse after start-up, then put into park, and the driver's door is opened (Figure 1).

Figure 1. Map section is blank in the instrument cluster display.

- Update the MIB2 High infotainment system using either Method 1 or Method 2 according to TSB 2047576: *91 MIB2 High Software Update Instructions (PR Code 7UG)* and use SVM code indicated below:
