### 91 MIB2 High: rearview camera/overhead view camera does not turn on

91 21 99 2055026/6 May 4, 2021. Supersedes Technical Service Bulletin Group 91 number 20-35 dated November 10, 2020 for reasons listed below.

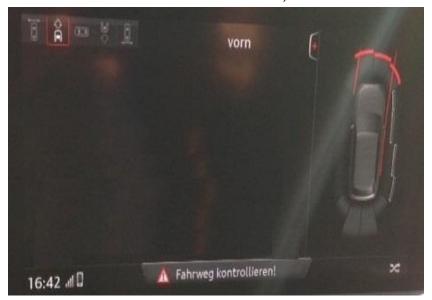
The picture of the top view camera is black and no guide lines are shown (Figure 2).

**Figure 2.** Camera picture without guidelines (vehicles with camera software 0318).

The MIB2 High software needs to be updated.

Update the MIB2 High infotainment system using either Method 1 or Method 2 according to TSB 2047576: *91 MIB2 High Software Update Instructions (PR Code 7UG)* and use SVM code indicated below:
