2019FA07, Rev. F  
April 09, 2021  
Product Code(s): 65, 66  
Page 1 of 16

**SUBJECT:** Special Coverage for TIDB Aluminum Main Valve Body – Reactive

**MODELS AFFECTED:** 3000 Series™, 4000 Series™, B 200, B 300, B 3400 xFE™, B 400, B 500, T 200, T 300, T 400, T 500 Models

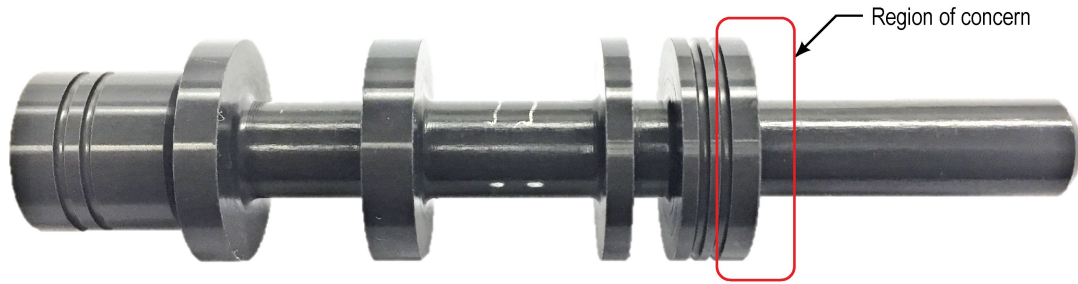
**Figure 1.**

**NOTE:** Closely inspect the Main Regulator Valve P/N 29563501 for the presence of a manufacturing burr shown in [Figure 1](#) and [Figure 2](#) below. See [SIL 01-WT-20](#) for additional clarification.

**NOTE:** Prior to re-using the PS1 Switch Assembly or PS2 Switch Assembly, closely inspect the O-ring of each switch for damage. If either O-ring is questionable, replace the part.
