# Ferrari North America Technical Information

| Bulletin #: | 2757 |

Model: **SF90 STRADALE**  
Subject: Air Conditioning Node (NCL) software update

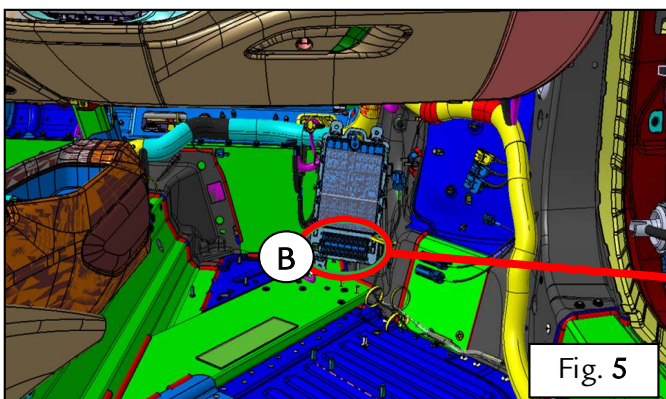
Fig. 5

- With the vehicle in “Sleep” state, disconnect the power feed fuse of the NIT F110, situated in fuse box FRB C312-LA (A) – Fig.5 and 6.

- At the end of the procedure, remember to save the identification parameter for the selected node.
- After completing installation of all the software necessary, check that the version installed is effectively **03.01**.
- Set the vehicle to **KEY OFF** state.
- Refit fuse **F110** of the **NIT** (Fig. 5 and 6). It is not necessary to wait for the network to enter “**Sleep**” state.
