Preliminary Information

PIP5800 Lack of Power or Poor Performance During High Ambient Temperatures with RPO (C7N) 12,300 LB GVWR or (C4M) 9,900 LB GVWR

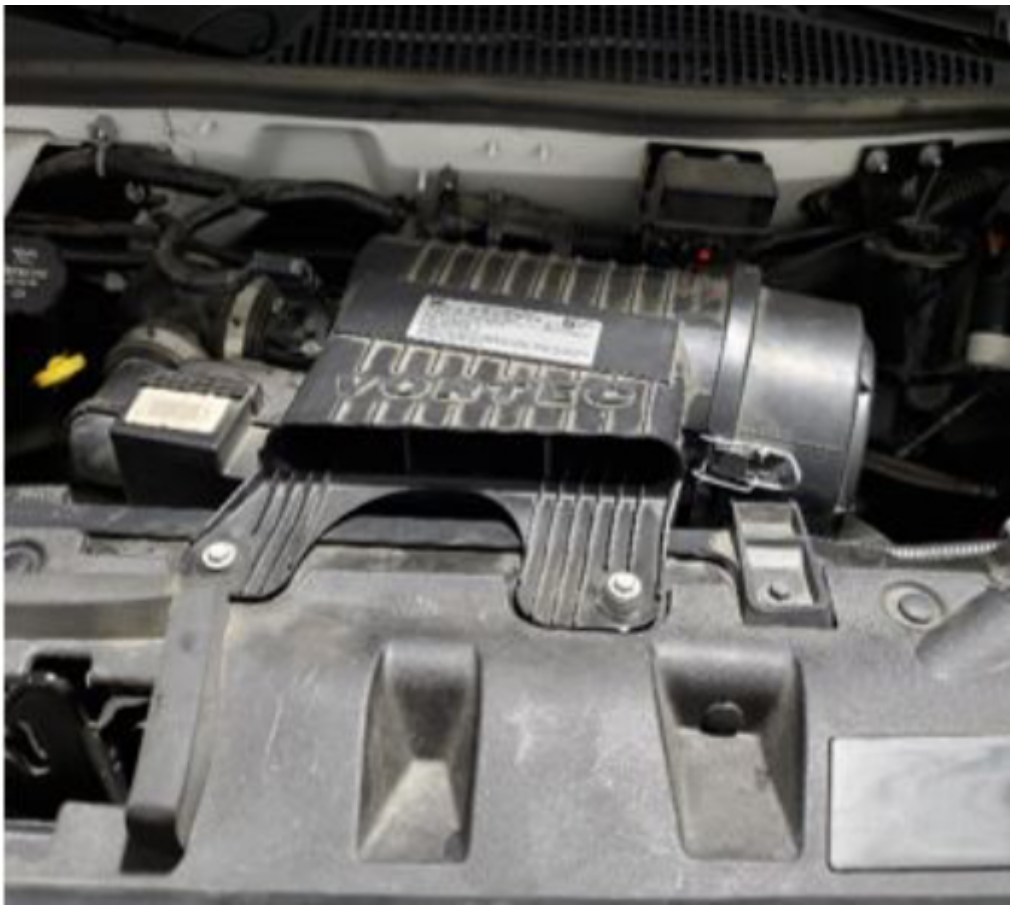
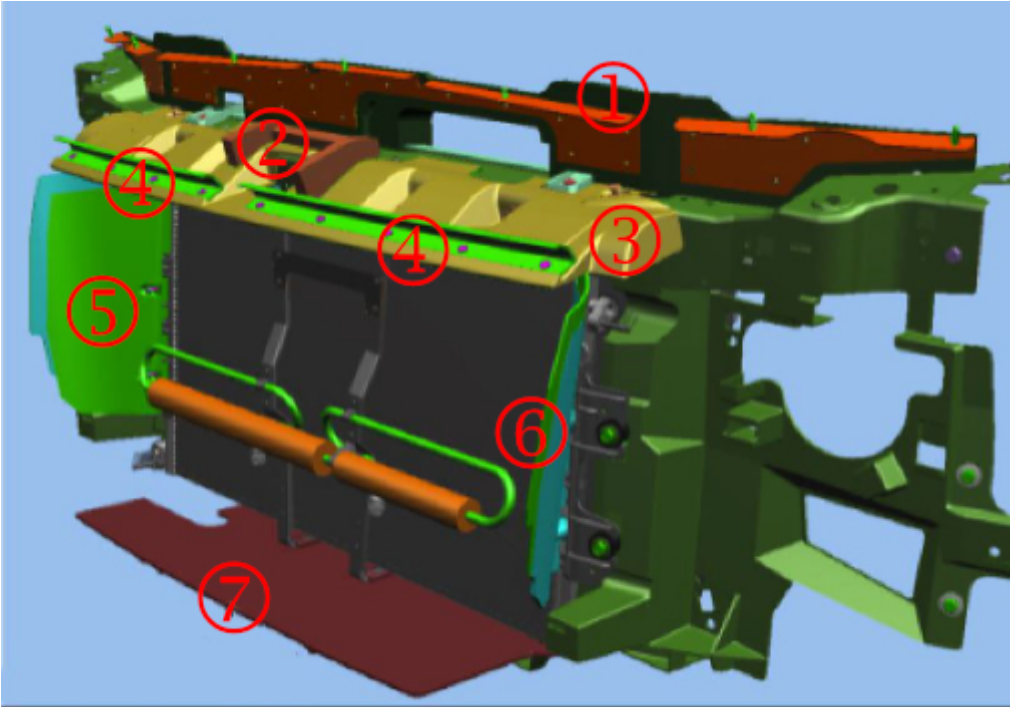
Are there any DTC current or in history? If so, please list them		
Are the vehicles maintained in-house or taken to dealerships?		
How long does the vehicle idle? What was the outside temperature when the condition occurred?		
Did the vehicle have any check engine lights or warning messages (What was the reason for service visit)?		
Inspection: with 100% accelerator pedal apply during acceleration does MAP nearly equal the Barometric Pressure value? If not, check induction system for restriction		
Ensure there are no exhaust restrictions. Refer to service information for exhaust inspection and back pressure check.

Inspect the intake duct for any restrictions.
