Bulletin No.: PIT5834A

PIT5834A A/C Blows Warm Intermittently Or Takes A Long Time To Start Cooling

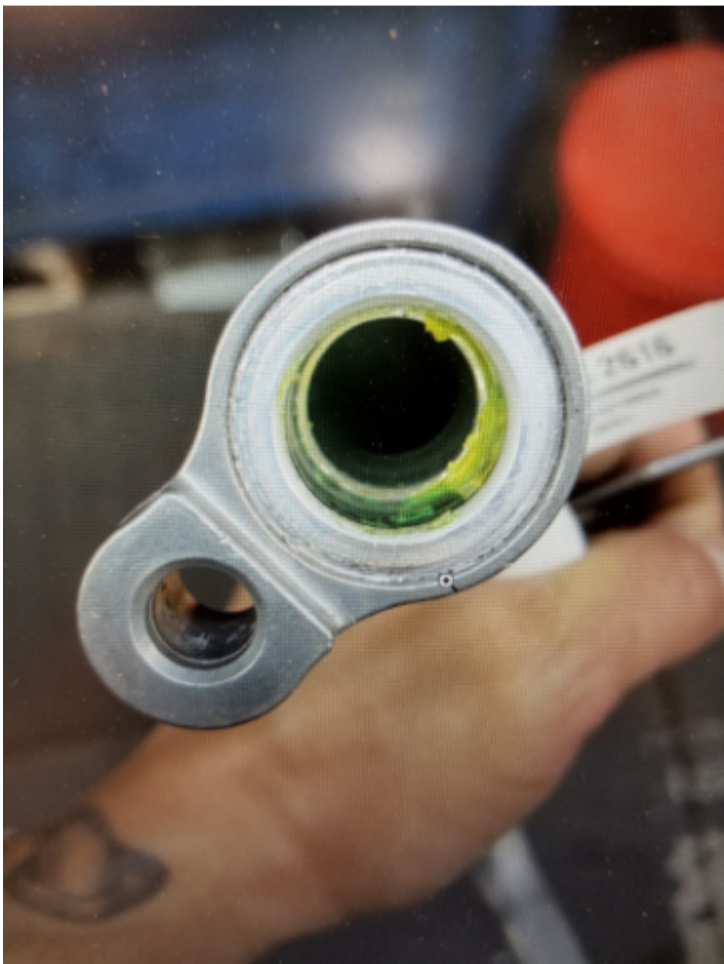
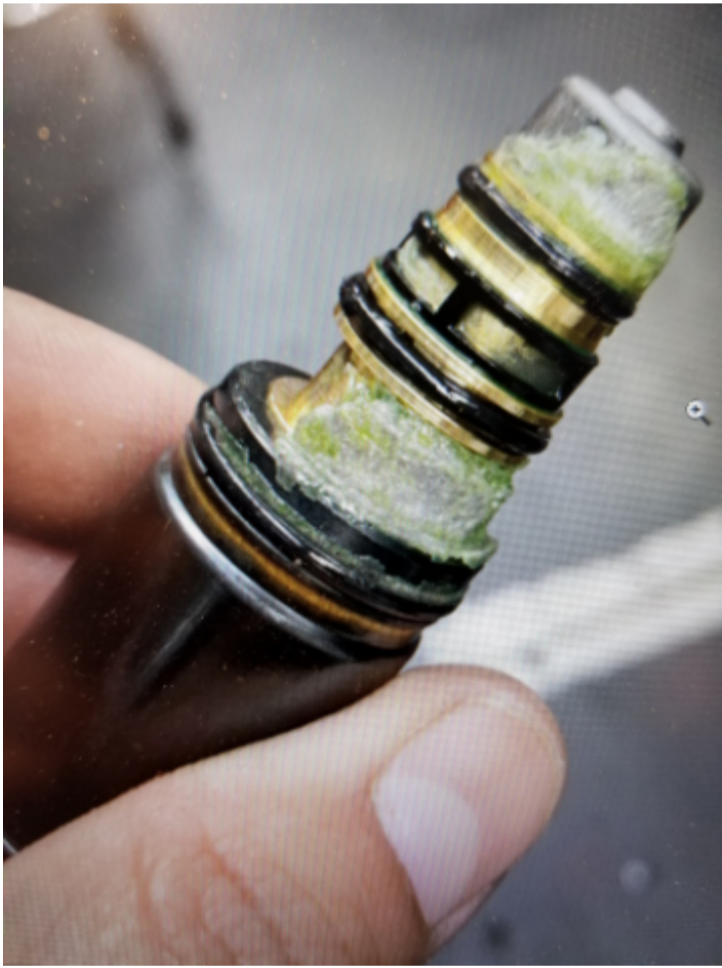
Involved Region or Country:	North America
Condition:	A/C is slow to cool, takes longer to blow cool air when compared to like vehicle.
Cause:	Possible A/C refrigerant contamination.

If you duplicate this condition and there is a noticeable performance difference when compared to another Blazer or Equinox and the vehicle was built during the above time period, recover the refrigerant using the GE-50957 Contaminated Refrigerant Recovery Machine. Remove the line from the condenser and the TXV and look for contamination like illustrated in the pictures below. If you have this contamination, take pictures of the fittings, open a TAC case and attach them to the case. Your case will be reviewed and you will be contacted directly. If you do not see visible contamination like below reinstall the lines and diagnose using the performance chart and diagnostics in Service Information.
